Abrasion process between a fibre mooring line and a corroded steel element during the transit and commissioning of a Marine Renewable Energy device

This paper brings together two experiences from TTI (Tension Technology International) and the UoE (University of Exeter) and aims to quantify the damage that could be experienced by fibre mooring lines during the transit and commissioning phase of Marine Renewable Energy (MRE) devices.

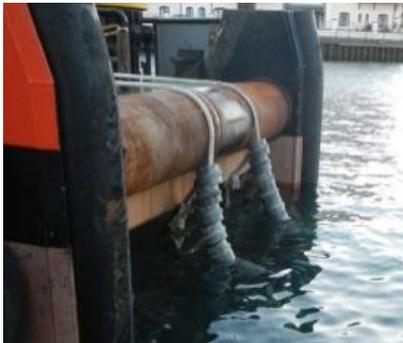
Figure 1. Anchoring system over the roller when connected to the vessel winch

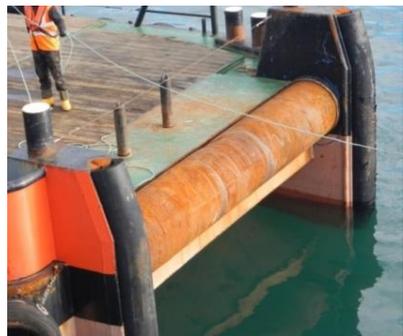
Figure 2. Roller after the operation: Polished marks are visible indicating friction between the roller and polyester rope

The first damaged section is shown in Figure 3 at 5.5m over 14 plaits. Although the steel roller of the vessel appeared smooth, seven strands were worn through. Rust contamination (caused by the rope sliding over the roller, Figure 2) can be observed by the discolouration in Figure 3.

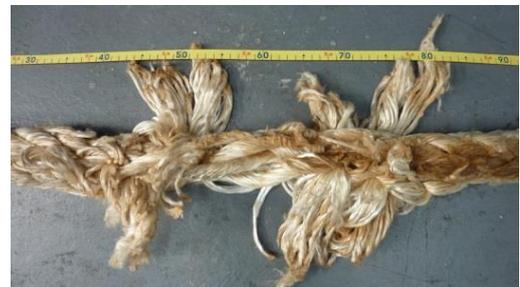
Figure 3. Damaged line at 5.5m

The outer yarn breaking load was slightly lower than the inner yarn breaking load due to some minor surface abrasion. The rope residual strength was found to be 92% MBL for the un-abraded section and 68% MBL for the abraded section adjacent to the failure. Outside the damaged area of the line, the tensile strength of the rope is still within limits of usability.

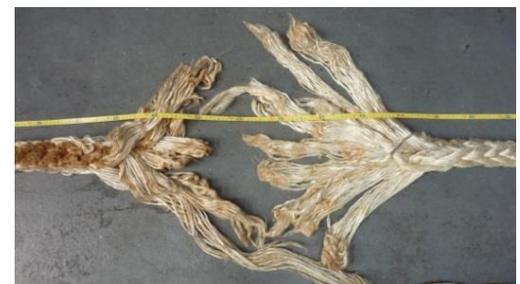
The second damaged section is shown in Figure 4 at 10.8m where most strand ends failed at the same location. Wear damage was sustained over 12 plaits, thus affecting every strand in the rope, with evidence of the fibres being heated. Localised melting resulting from friction is visible in small quantities at the failed section.

Figure 4. Damaged line at 10.8m

The same calculation was performed for the section presented in Figure 4 where five strands remained on the rope. This section is the other leg of the drawstring that was equally loaded and abraded and thus best represents the residual strength at the time of the failure in the other leg. For this section the residual strength was found to be 14% MBL. The numerical model detailed later in this paper indicated that the simulated load was greater than the measured residual strength.

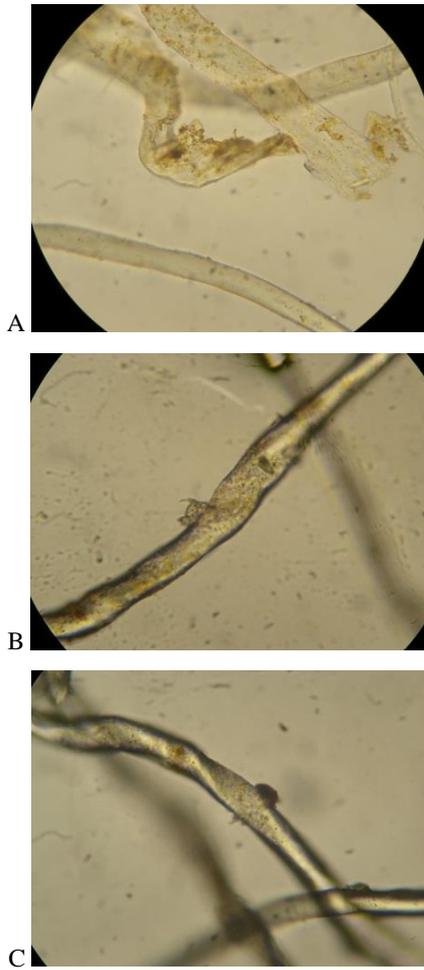
SEM was used to identify the cause of fibre damage. Most of the yarns presented evidences of abrasion damage. Fibre fracture and fibre peeling can be observed on Figure 5 A and B respectively. These damages are typical of situations where the fibres are heated by friction forces.

However, a few SEM fibre specimens were observed to be distorted as shown in Figure 5 C. This could be the effect of the heat or the high contact pressure.

Figure 5. SEM micrographs of damaged yarns

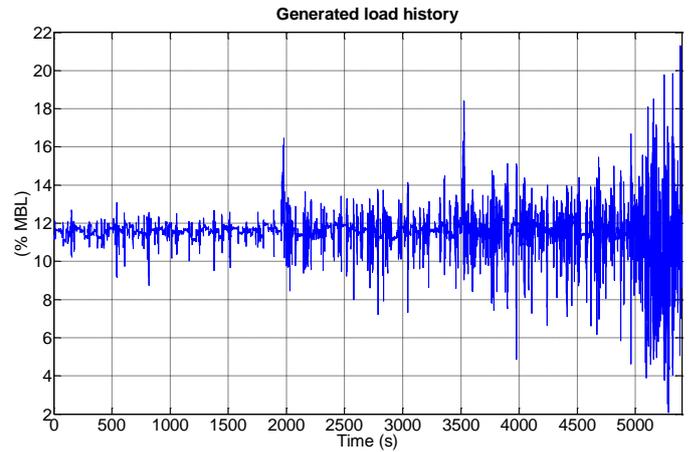
During transit the polyester rope mainly experienced low amplitude loads with intermittent higher amplitude load cycles for the first 5,000 seconds. During the last 400 seconds of the simulation, the load amplitude is up to three times larger. Some peak loads higher than 20% MBL are visible. This short period of 400 seconds correspond with the moment where the vessel manoeuvred at the vicinity of the targeted site.

Figure 10. Load history of the polyester line for a 90 minute simulation representing the conditions up to failure

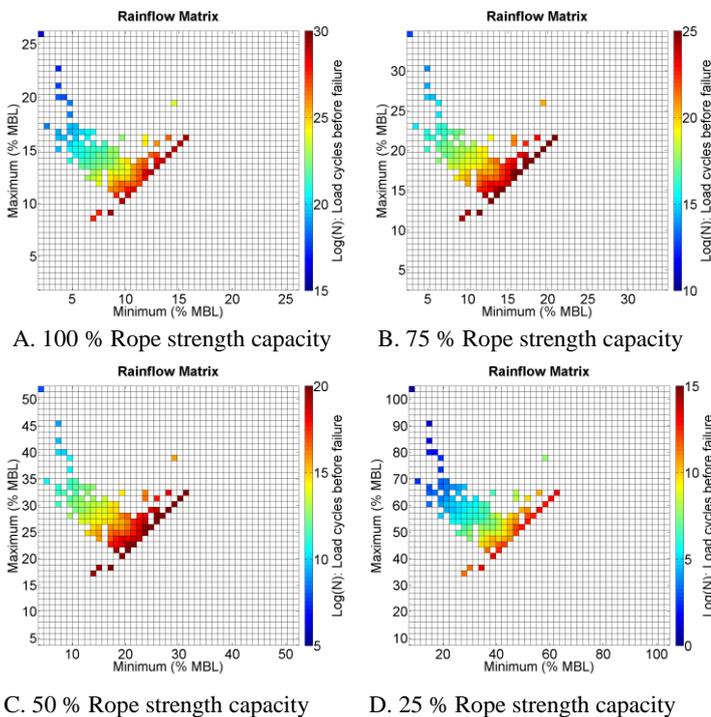
Figure 14 is obtained by combination of Figure 12 and Figure 13. These four figures show the number of loads cycles for each load range emanating from the simulated load history to reach the failure. Figure 14 A represents the number of load cycles before failure at the early start of the operation, i.e. when the polyester line was new and un-abraded. The simulated load history would have not been important enough to cause the failure on the rope if un-abraded for the entire period of commissioning. The same conclusions can be drawn for a remaining rope strength capacity of 75% and 50% respectively shown in Figure 14 B and Figure 14 C.

However, in case of severe abrasion (i.e. with 25% remaining bearing capacity as shown in Figure 14 D) the load range will have increased up to the equivalent of 100% of the abraded rope's MBL. As forces have to be withstood by a reduced cross-section, it will have weakened the remaining rope before failure. As the abrasion mechanism is dynamic with time and loads, it is however difficult to quantify the exact fatigue contribution.

Figure 14. Rainflow matrix showing the number of load cycles before failure

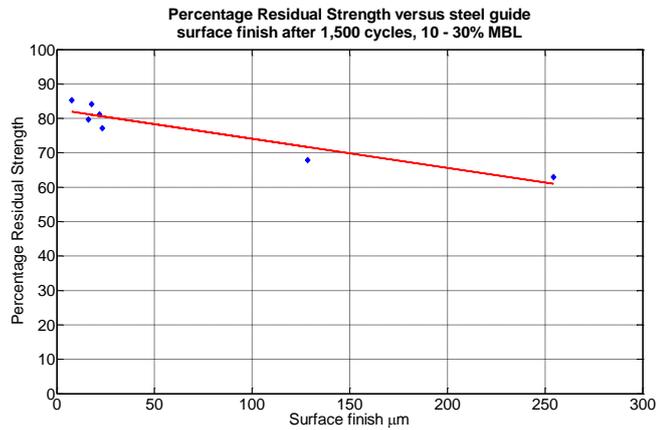
The effect of the surface finish of the steel guide on the percentage of residual strength is shown in Figure 15. A linear trend is visible demonstrating that a rougher surface finish will lead to higher rope damage and lower resultant residual strength. The second test used the roughest steel guide surface (254.3 μm) and had thus resulted in the highest strength loss (38%). In the same way, the smoothest steel guide surface (7.6 μm) on the test 3 resulted in the lowest strength loss (15%). These observations correspond proportionally with the number of damaged yarns in Table 4: The rope of the second test was reported to have the highest number of damaged yarns (151 damaged yarns) and the rope of the third test were reported to have the lowest number of damaged yarns (51 damaged yarns).

Figure 15. Strength loss against surface roughness (values listed in Table 2 and Table 4)
