Communication

# Citizen Science Tools Reveal Changes in Estuarine Water Quality Following Demolition of Buildings

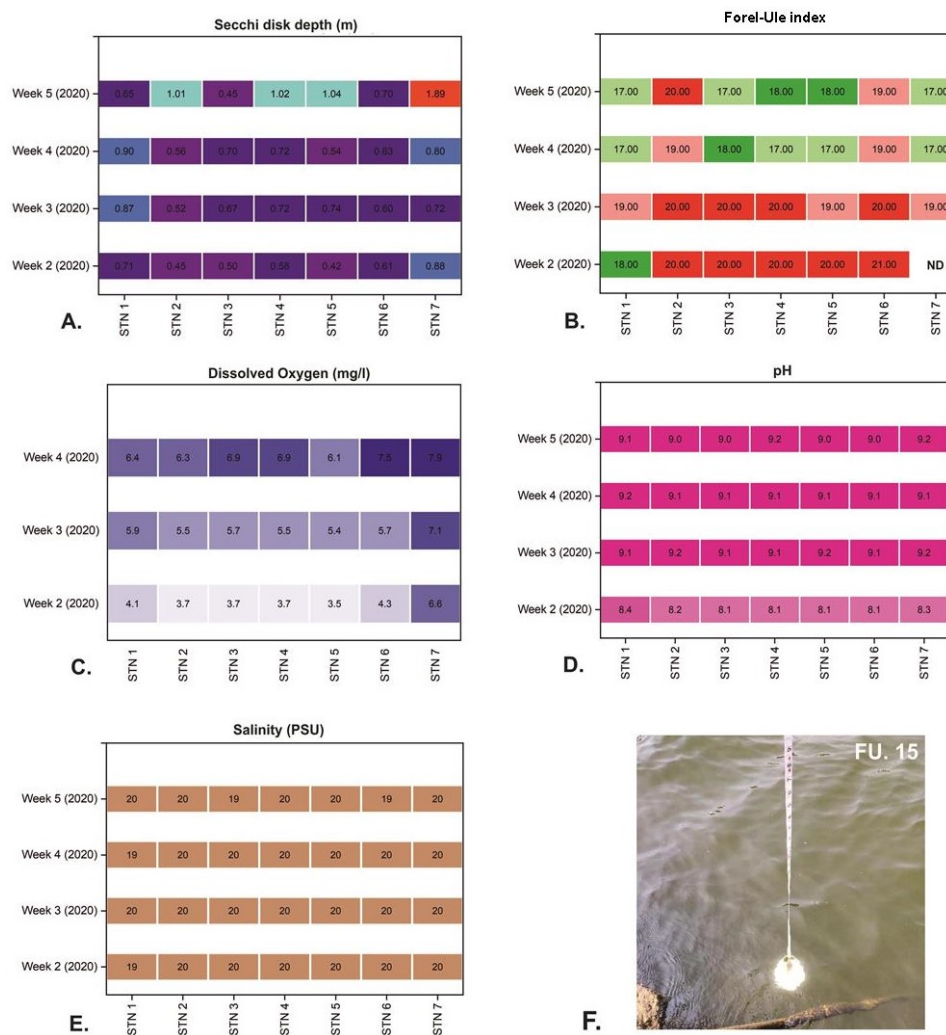
**Figure 2.** Variation in (A) Secchi depth (m), (B) water colour (Forel-Ule index), (C) DO ( $\text{mg L}^{-1}$ ), (D) pH, and (E) salinity (psu) values at the 7 stations post demolition. (F) shows a sample photograph taken by citizen scientists of the water while operating the 3DMSD. ND—Not Determined.

Water was brown in colour (i.e., FU >18) as observed two weeks after demolition (Figure 2B). This colour was due to a high load of suspended particles in the water column. Similar colour indices had been previously detected in the Vembanad Lake only in June and were attributed to resuspension of sediment due to high mixing during the southwest monsoon, as well as to the transport of sediment-rich waters into the lake by the numerous rivers that discharge into the lake. With increasing duration after demolition, there was a general decrease in FU colour (17) at most stations, but it did not drop to 15 or below, i.e., green or blue colour indicating clearer waters, during the sampling period [16].

Salinity was found to be consistently high throughout the sampling in 2020 (19–20 psu) (Figure 2E), reflecting the samplings at high tide. There was no significant change in salinity from week two to week five after demolition (Table 1), suggesting little influence of other factors (e.g., precipitation or changes in tidal currents) on our findings.

The pH showed a steady increase in all stations from the second to the fifth week after demolition (Figure 2D). Significant increase in pH was evident during the third ( $M = 9.11 \pm 0.04$ ,  $p < 0.05$ ), fourth ( $M = 9.1 \pm 0.05$ ,  $p < 0.05$ ), and fifth ( $M = 9.07 \pm 0.09$ ,  $p < 0.05$ ) weeks compared with the second week ( $M = 8.18 \pm 0.12$ ). It is known that cement effluents increase the alkalinity and pH of the receiving water [22]. The chemical composition of cement used for construction is comprised of calcium silicate hydrates, which include oxides of calcium (CaO) and silicon (SiO<sub>2</sub>), with lesser amounts of aluminum oxide (Al<sub>2</sub>O<sub>3</sub>) and iron oxides (Fe<sub>2</sub>O<sub>3</sub>). These are subsequently polymerized into a densely-cross-linked matrix [23–25]. When brought into contact with water, the first hydration product capable of leaching from cement-based material is reported to be calcium hydroxide [24,25]. Addition of hydrated lime to water increases the pH of the system [26], and the rate of leaching increases with the surface area of the concrete in contact with water [25]. It has been reported that leaching of hydroxyl ions from cement increases with time and that the cumulative leaching rate is found to be higher in flowing water after three days and continues to increase over a further period of time [27,28]. This could be the reason for the sustained increase in the pH of the water even five weeks after demolition.

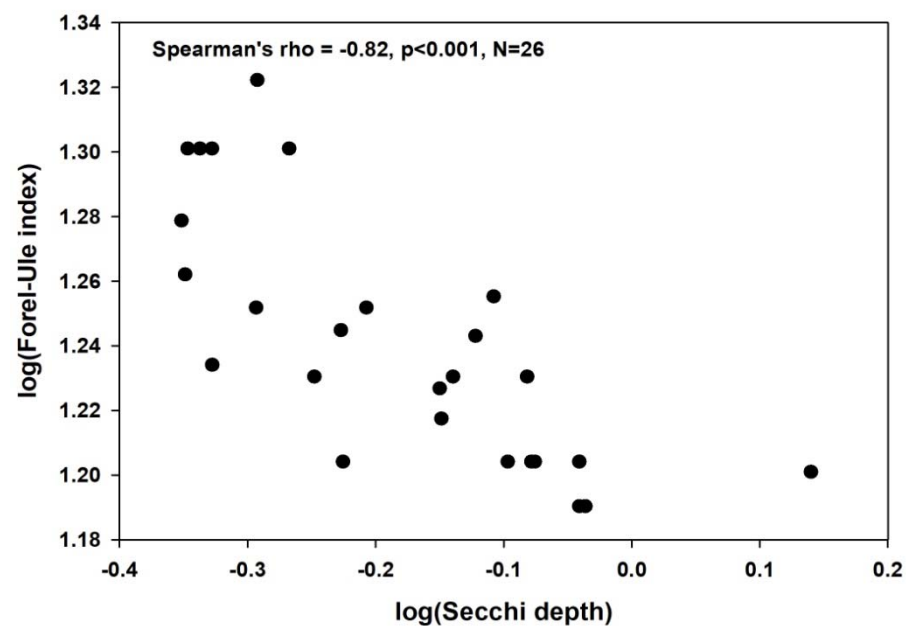
**Figure 3.** Spearman's rank correlation test statistics from weekly averaged FU Index and Secchi depth of the 7 stations during the 5 weeks after demolition. One outlier (−1.1 log SD and 1.26 log FU) was removed from the samples (N = 26).

Supporting the quality of our citizen observations, we observed a strong inverse relationship between the FU colour and Secchi depth (Figure 3). This is consistent with the finding of Garaba et al. (2015) [19] that the apparent colour darkens as water becomes muddier and turbidity increases with increasing suspended particulate and dissolved material (higher FU colour codes—brownish waters). A correlation test (Figure 3) helped in proving the utility of an inexpensive and simple technique and easy recording of readings in water quality assessment.

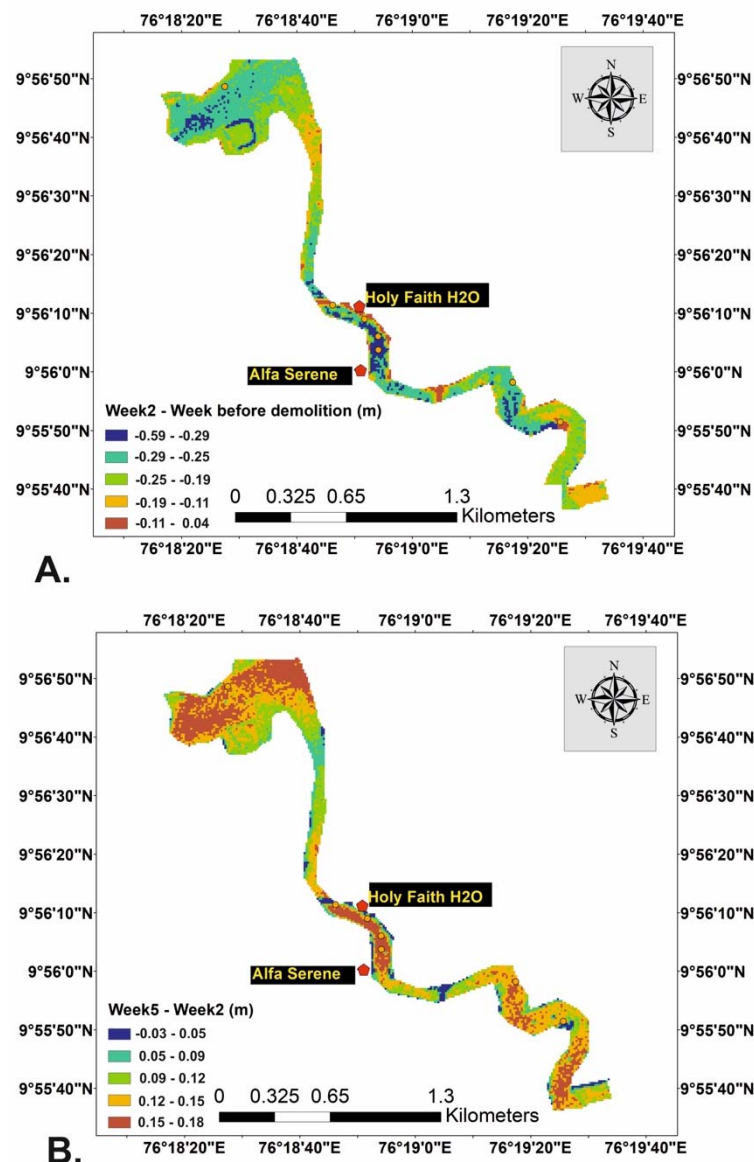
**Figure 4.** Difference in Secchi depth between weeks as derived from Sentinel 2A and 2B. (A) Second week after demolition—One week before demolition. (B) fifth week after demolition—second week after demolition.

Though the satellite observations yielded Secchi disk observations that were generally in the same range as the in situ observations, there was a systematic over-estimation of Secchi depth compared with the in situ observations when weekly averages were compared. This difference could have been for a number of reasons, including the use of weekly averages for the comparison, and the differences in the scales of observation, apart from the use of an algorithm that had been established for Portuguese waters. We therefore focused on relative changes observed in the satellite data. The comparison of the Secchi depth distribution during week 2 after demolition with that from the week before demolition exhibited significant reduction in Secchi depth by about 0.59 m along the demolition sites, owing to the increased turbidity from debris (Figure 4A). This information, which could not be obtained from in situ sampling, provides further evidence that the water body was exposed to decreased water clarity due to the demolition. Corroborating the in situ observation, an improvement in water quality was evident in the satellite derived data also by the fifth week after demolition, with the Secchi depth at the demolition sites different by as much as 0.18 m compared with that of the second week (Figure 4B).

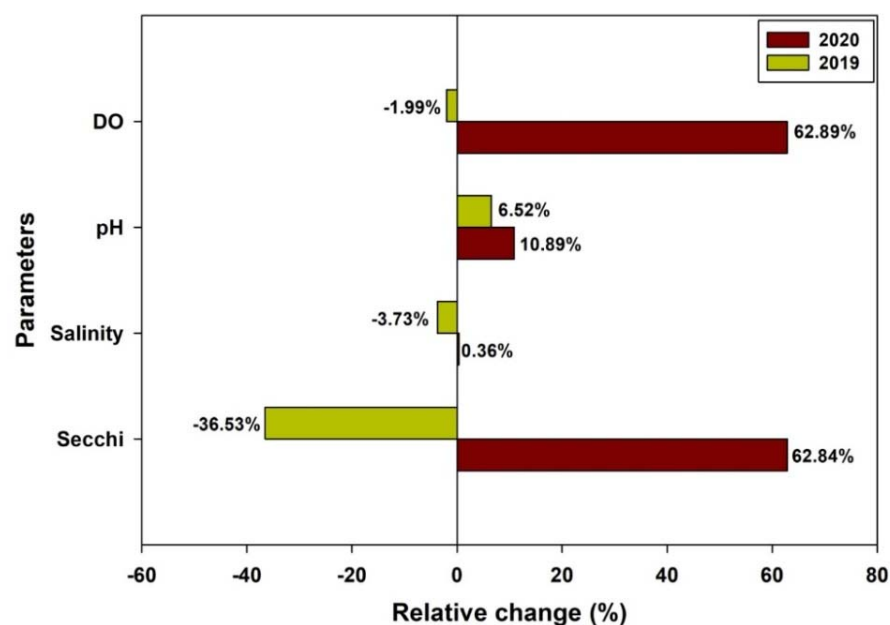
**Figure 5.** Percentage change in the variation of the water quality parameters in 2019 (pre-demolition) and 2020 (post demolition).

To examine if the changes in the environmental parameters were natural variations, data on the same variables during five weeks of same time period (January–February) in 2019 were subjected to paired *t*-test between weeks. However, none of the parameters (salinity, pH, DO, and Secchi depth) showed significant variation with time ( $p > 0.05$ ) in the 2019 dataset. Relative variability in the observations in the two years (Figure 5) shows higher variability in 2020, especially with respect to DO (62.89% in 2020) and Secchi depth (62.84% in 2020). The small difference in the relative change in pH (10.9% in 2020 compared with 6.5% in 2019) may be misleading, as pH is based on a log scale, so even a small change can have enormous physiological ramifications. Such sudden fluctuations in pH of the system can affect the survival of estuarine organisms and hence the relative change is of high significance from the point of view of ecosystem health. SDG 14—life under the water emphasises that quality of water determines the life under water. The results bring to the fore the urgent need to shift to sustainable development pathways for the sustenance of the estuarine ecosystem.
