A combined remote sensing–numerical modelling approach to the stability analysis of Delabole Slate Quarry, Cornwall, UK

Mohsen Havaej ^a, John Coggan ^b, Doug Stead ^a, Davide Elmo ^c

1. Abstract

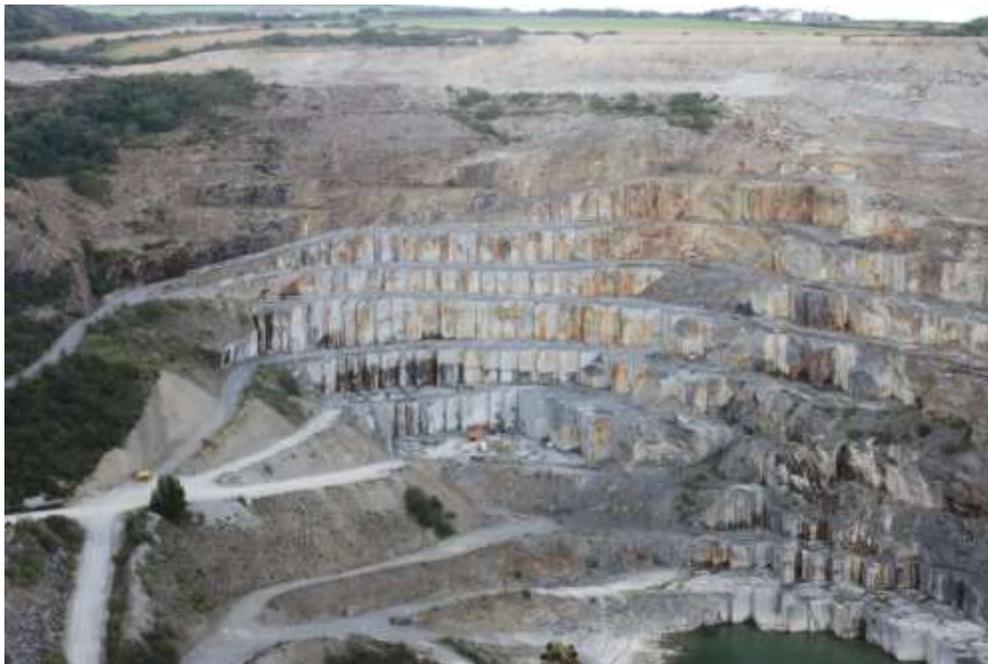
Figure 2. Photograph of the north/north-east slope taken from the south of Delabole Quarry looking north; overall slope height is approximately 150 meters, bench heights are between 4 to 10 meters

Current production at the quarry is limited to the north-east region, where 4-10 m high near-vertical benches are formed by diamond impregnated wire sawing (Figure 2). This excavation technique results in minimal damage to the slate, thereby increasing product recovery. In view of limited rock mass damage the quarry provides an excellent site for investigating rock mass characteristics and potential for discontinuity-controlled instability without having to evaluate the detrimental effects of blast-induced damage to the rock mass. The quarry is currently undertaking a push-back on the upper benches of the north-east region in order to provide access to high quality slate in the central and lower sections of the slope. This is being undertaken using mechanical excavation, with waste material being placed within the west and south regions of the quarry.

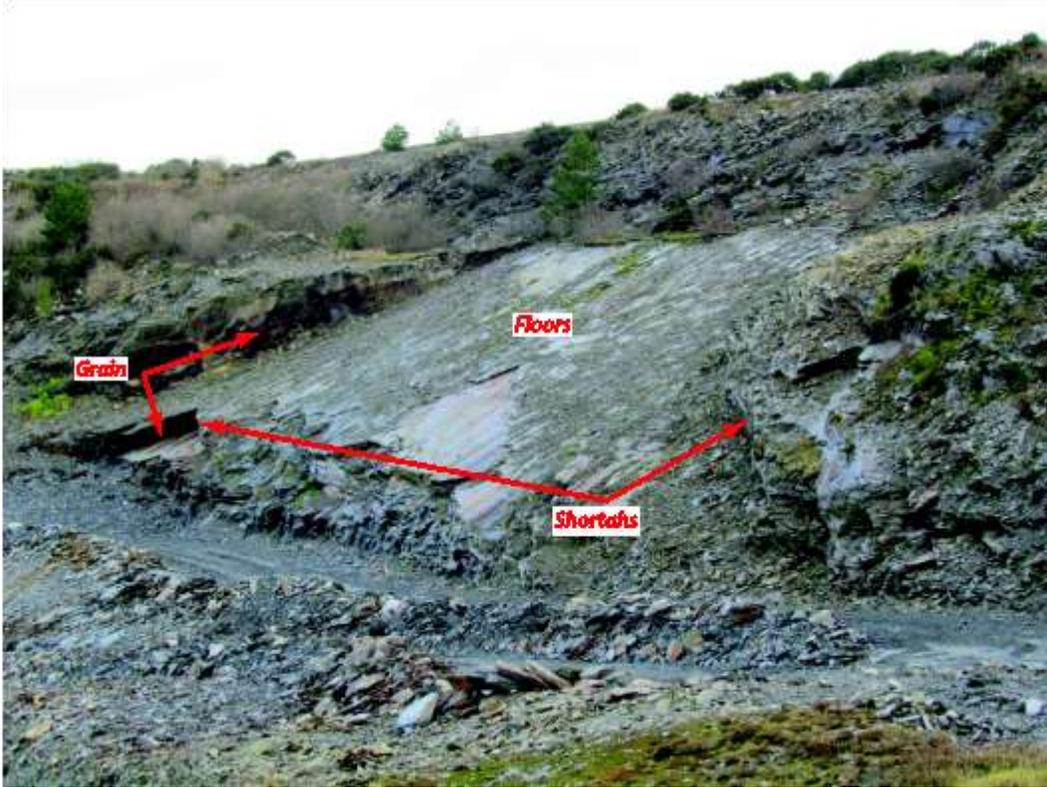
Figure 3. The 2012 planar failure on the upper bench of north-east Delabole Quarry slope and showing the discontinuity sets that caused the failure; the strike length of upper section of the failure is 50 m

Evidence of the potential for discontinuity-controlled instability on the north-east slope can be seen in Figure 3, which shows an image of a recent 50 m wide and 13 m high planar failure on an upper bench. Crack opening was observed by the quarrymen at the crest of the bench during regular inspection and the unstable section safely removed. The basal surface of the failures shown in Figure 3 is provided by Floors with lateral release surfaces provided by Shortahs and Grain. The failures highlight the three-dimensional nature of the potential failure due to blocks formed by the discontinuities and the influence of bench-face orientation on the likelihood for instability.

Previous studies by Costa et al. (1999) highlight the potential for planar failure to occur on the Floors within the north-east slope depending on bench orientation and shear strength of the discontinuities. Observed instability (shown in Figure 3) suggests that failure may also be influenced by potential lateral release surfaces provided by a number of discontinuities including both the Grain and Shortahs. A preliminary investigation of the kinematics of potential instabilities within the north/north-east slopes was undertaken using Swedge V. 6. 0 (Rocscience 2014b). Within the Swedge model, the Floors discontinuity was considered as a basal failure surface. This analysis examines the possibility of rock slope failure due to the unfavourable orientations of discontinuities. Considering the three discontinuity sets (Floors, Grain and Shortahs) within the model a wedge is formed (Figure 11). The mean values of the discontinuity set orientations (Table 3) are considered in the Swedge model. Shear strength properties within the model are based on the results of laboratory and field tests provided in Costa et al. (1999) for distinct element modelling of the north-east slope (Table 5). Using the shear strength properties shown in Table 5, the wedge is stable with a factor of safety equal to 1.7. Only when the friction angle of the basal surface is decreased to 20° does the model become unstable.

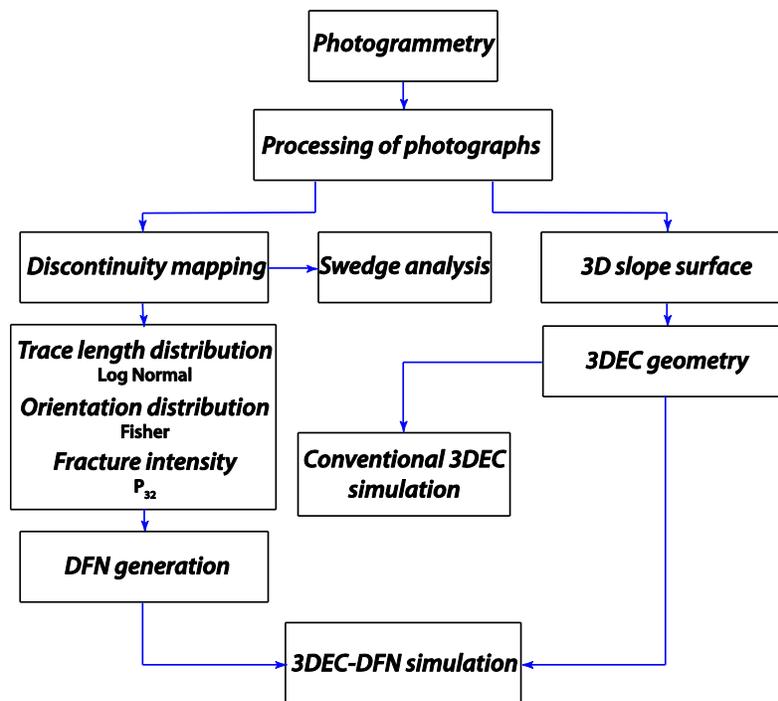
Figure 4. Methodology adopted for rock mass characterization and subsequent numerical simulations

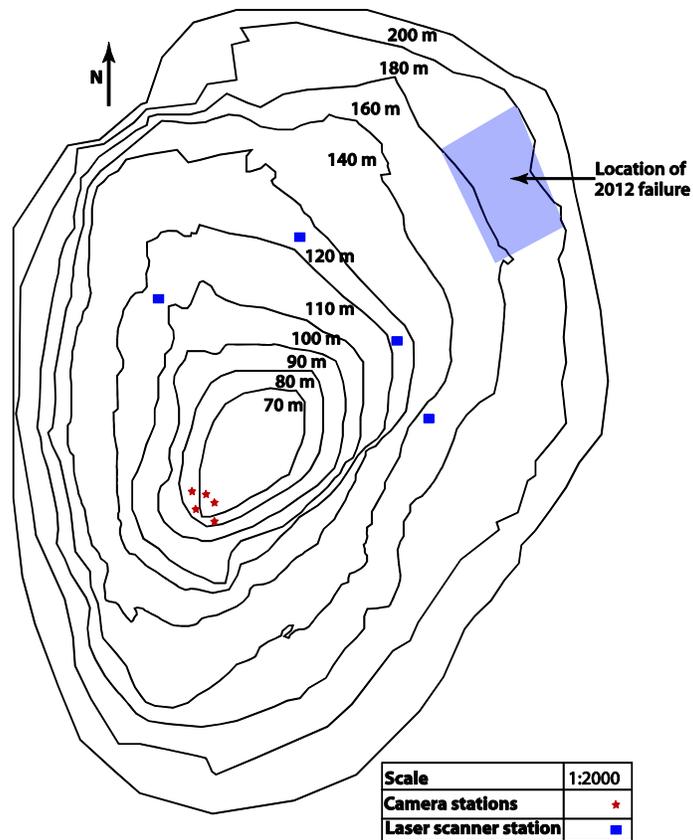
Figure 5. Plan view of Delabole Slate Quarry illustrating the locations of camera and laser scanner stations (after Shillitto 2013)

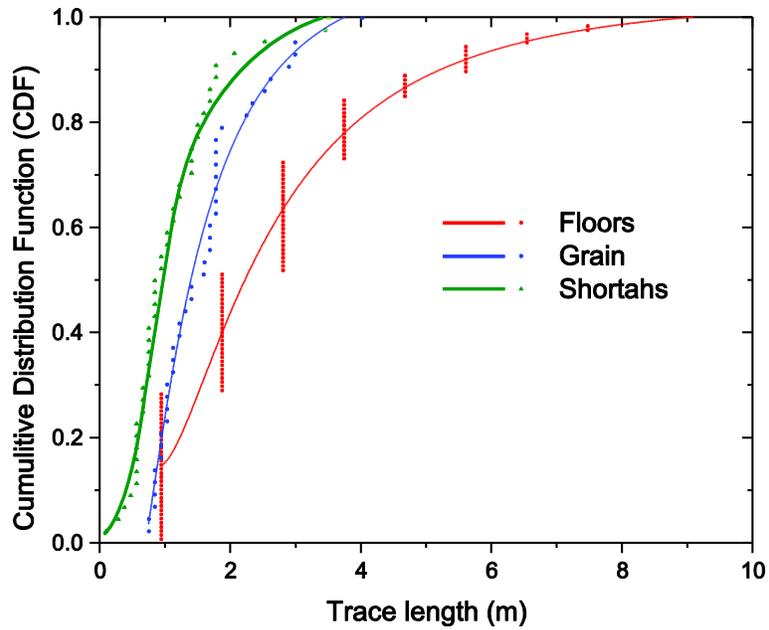
Figure 8. Cumulative Distribution Function of trace lengths for the three discontinuity sets (Floors, Grain and Shortahs) and Log Normal fit assigned to the data (each dot represents a discontinuity measurement and the lines show the Log Normal fit assigned to the data)

In this study, the Log Normal distribution was found to provide a good fit to the discontinuity trace length data. Figure 8 shows the Log Normal fits assigned to the Cumulative Distribution Function (CDF) plots of trace length for each discontinuity set in order to determine the corresponding trace length distributions. A summary of the statistical parameters that describe the Log Normal distribution of the three discontinuity sets is provided in Table 3.

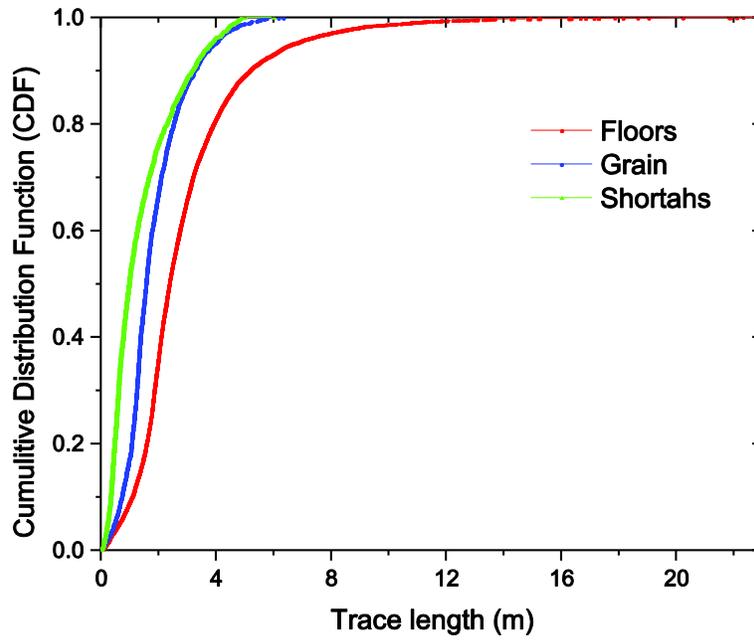
Figure 10. Cumulative Distribution Function of trace length of the three discontinuity sets (Floors, Grain and Shortahs) generated using the using the statistical parameters described in Table 3. Table 3

In order to validate the Log Normal distributions assigned to the trace length of the three discontinuity sets, a fracture network associated with each discontinuity set is generated in FracMan (using the statistical distributions presented in Table 3). The trace lengths of the synthesized discontinuities on the slope face are then analysed and compared to the trace length analysis for the mapped discontinuities (Figure 8). Figure 10 shows the Cumulative Distribution Function for the trace lengths generated using the DFN representing the three discontinuity sets. By comparing the range of trace lengths and

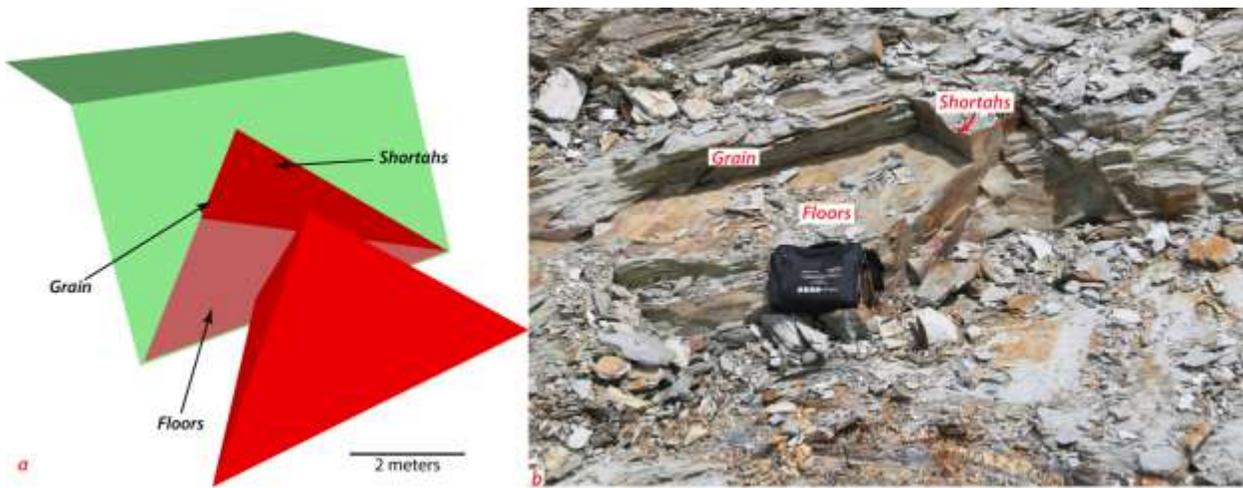
Figure 11. a. Swedge model illustrating a socket wedge formed by the three discontinuity sets (Floors, Grain and Shortahs); b. a small scale discontinuity controlled failure within the quarry slope

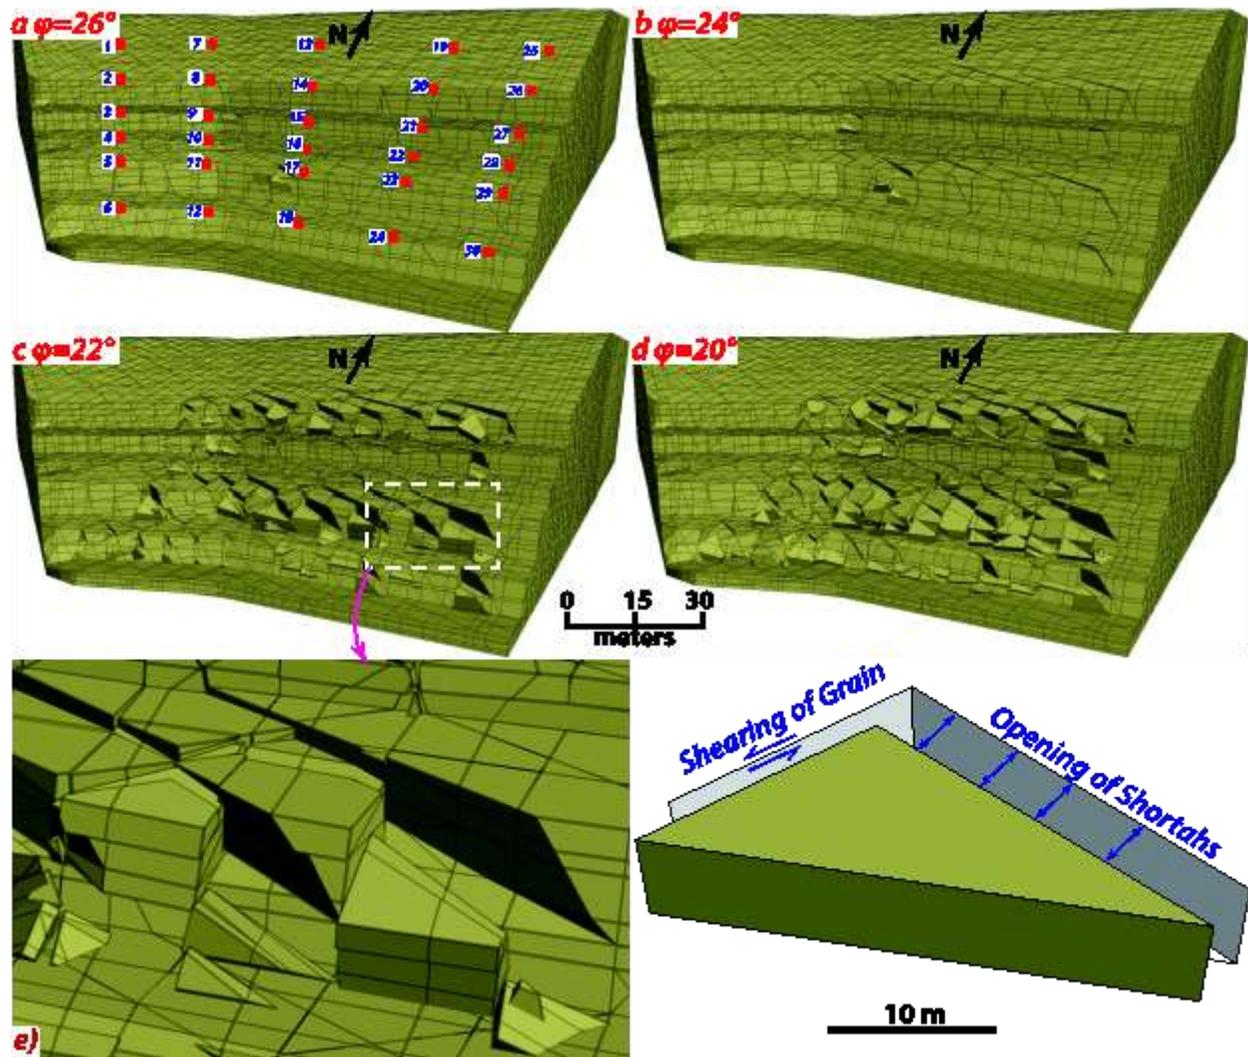
Figure 12. a. location of the network history monitoring points; failure of 3DEC models with varied friction angle of the basal surface (Floors); a. 26° , b. 24° , c. 22° and d. 20° ; e. Inset illustrating the failure mechanism, opening of Shortahs and shearing along Grain and Floors discontinuities

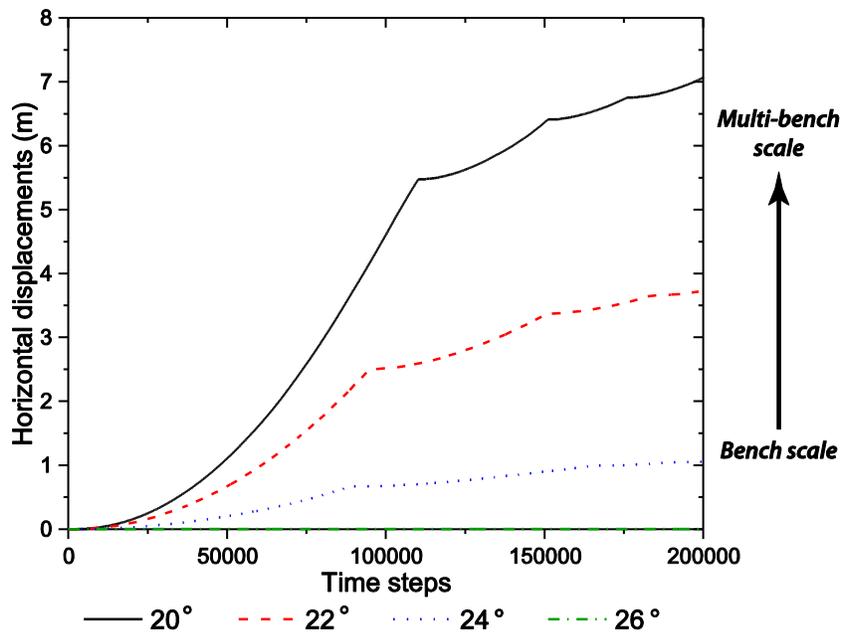
Figure 14. Recorded horizontal displacements for the models presented in Figure 12, with assumed friction angle for the basal surface (Floors)

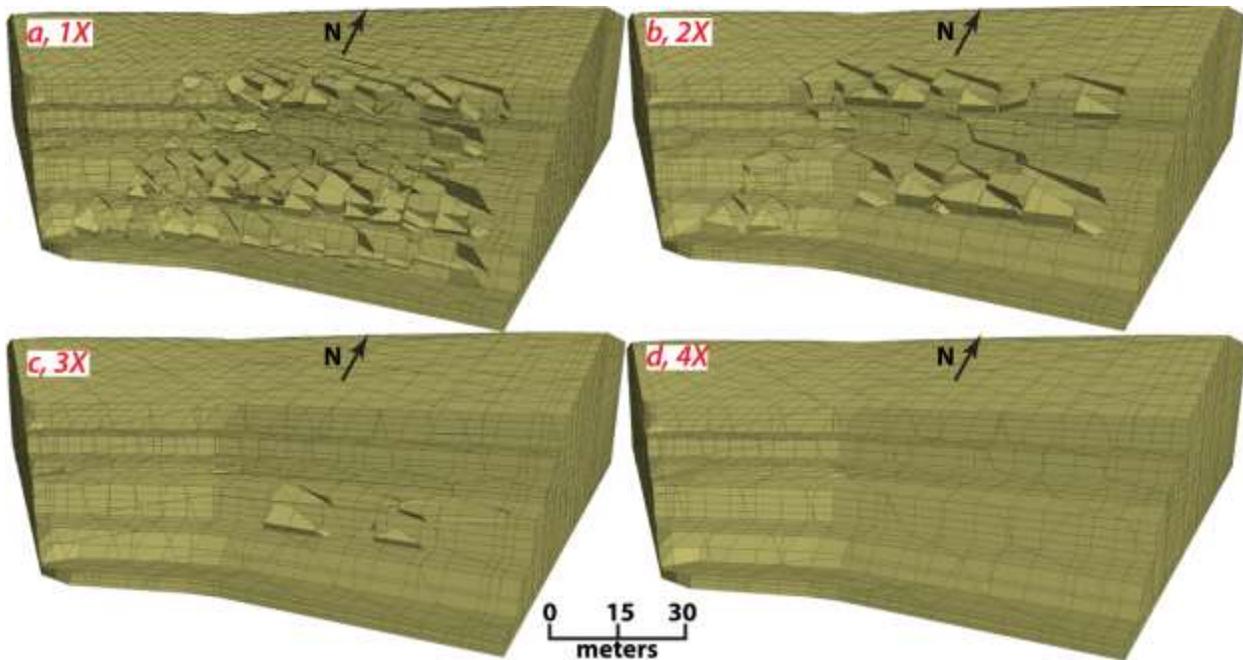
Figure 15. The effect of change in the assumed discontinuity set spacing on the simulated 3DEC failure mechanism; a. initial base model spacing, b. 2X, c. 3X and d. 4X spacing multipliers

A second series of 3DEC simulations was undertaken to investigate the effect of discontinuity set spacing on the potential slope failure mechanism. For these models, the friction angle of the basal surface was maintained at 22°. Four 3DEC models with increased spacing values were investigated. In these models, the original spacing values provided in Table 5 were multiplied by 2, 3 and 4 (Table 6). This was undertaken to maintain the observed in-situ relative block size aspect/dimensions. With an increase in spacing value by a factor of two, failure occurs at the inter-ramp scale (Figure 15b). When the spacing value is multiplied by a factor of three, failure occurs at the bench scale only with a significant decrease in the number of blocks involved (Figure 15c). Individual block failures only occur in the north-east part of the slope. A further increase in spacing (when multiplied by four) results in no significant displacements within the model, and the model appears fully stable (Figure 15d). Plots of horizontal displacements versus calculation time steps also show an increase in the model stability with increase in assumed joint spacing, highlighting the influence of modelled block size on model behaviour (Figure 16).

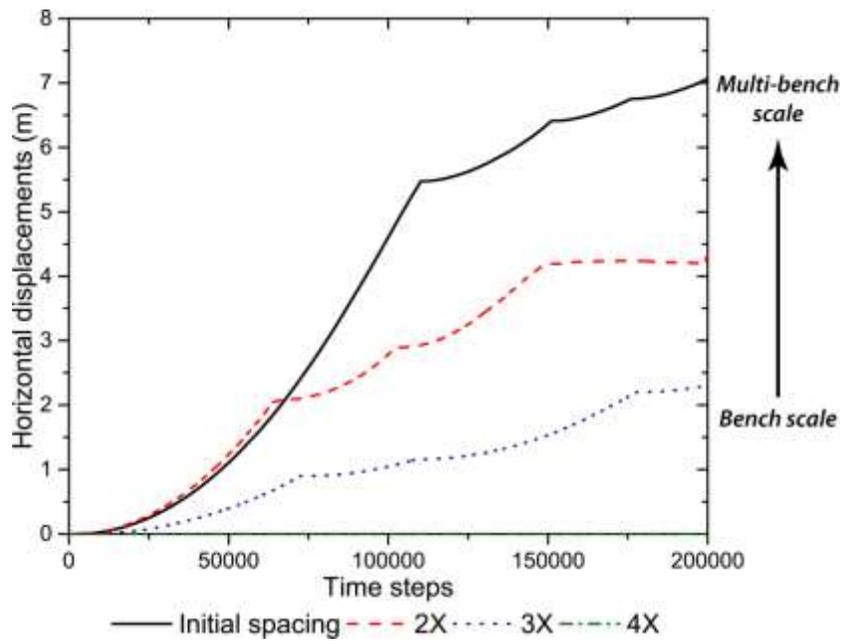
Figure 16. Recorded horizontal displacements for the models presented in Table 6Table 6, with varied joint spacing

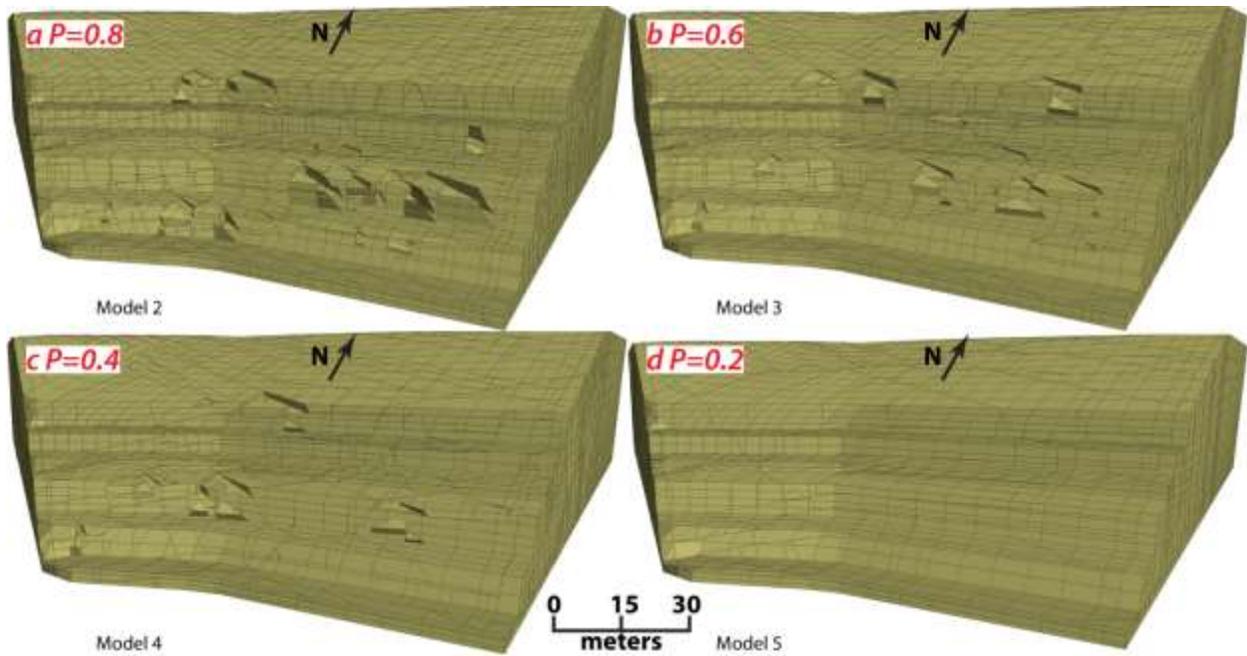
Figure 17. The effect of change in the persistence of the three joint sets on the modelled failure mechanism; a. $p = 0.8$, b. $p = 0.6$, c. $p = 0.4$ and d. $p = 0.2$)

assigned to a discontinuity, then on average 90% of the blocks will be split. (Brideau et al. 2012) used this method to investigate the effect of persistence on the stability of a concave rock slope. In this section we investigate the influence of persistence of the three discontinuity sets on the slope failure mechanism in the north-north east face of Delabole Quarry. The persistence value assigned to the basal surface is shown in Table 7. Block movements for the model assuming a fully persistent basal surface ($p=1$) were previously illustrated in Figure 12c. Decreasing the p -value to 0.8 significantly decreases the extent of failure particularly at the top of model (Figure 17a). The 3DEC slope model remains unstable at most of the benches (especially within the north-east section of the modelled slope). A further reduction in the scale of the failure is observed when the persistence value is further reduced to 0.6 (Figure 17b). Limited bench scale failure is observed when the p -value is decreased to 0.4 (Figure 17c), and no unstable blocks are formed when the p -value is decreased to 0.2 (Figure 17d). The recorded horizontal displacements for all the persistence models are presented in Figure 18. Models 2-4 show a continuous increase in the recorded displacements while model 5 is stable with insignificant horizontal displacements, highlighting the controlling influence of modelled persistence on slope behaviour.

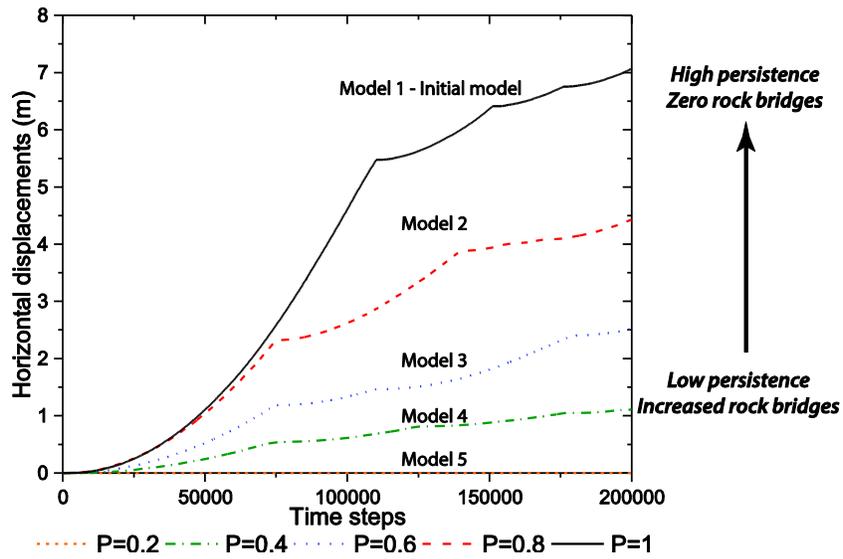
Figure 18. Recorded horizontal displacements for the models with varied persistence values

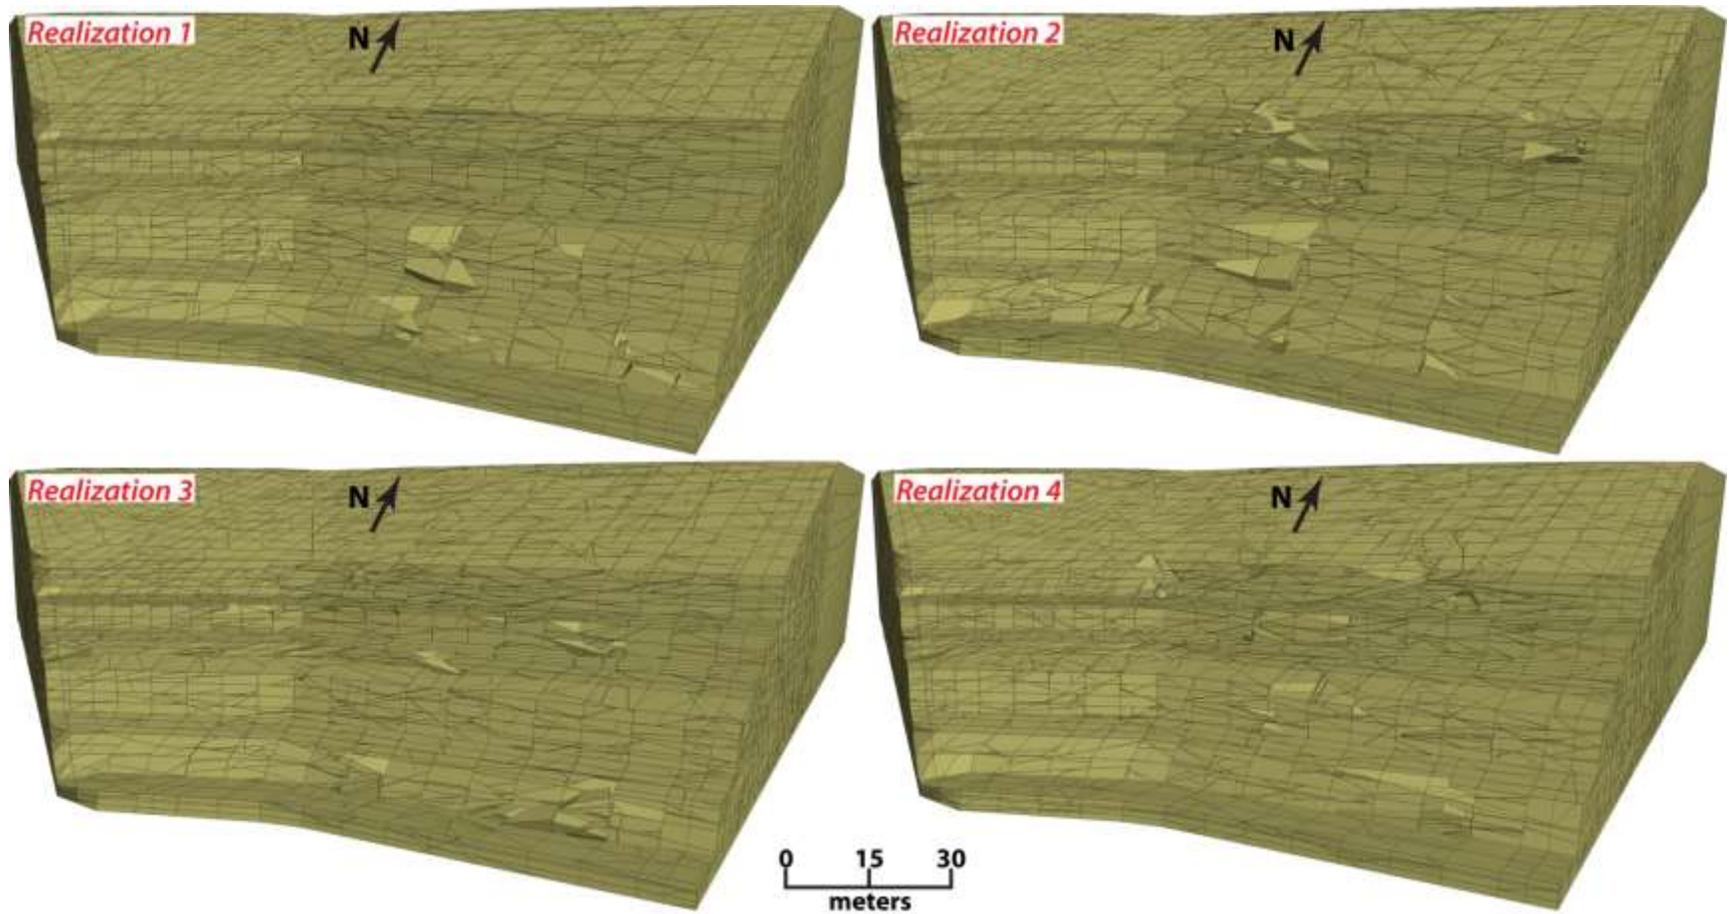
Figure 19. Block displacement plots for the four different 3DEC-DFN model realizations

Using the statistical parameters associated with the three discontinuity sets (Table 3), we developed discrete fracture networks which were then incorporated within the 3DEC models. Due to the stochastic description of the joint system, each 3DEC model has a unique realization of discontinuities therefore each generated DFN is slightly different. In this study four DFN realizations are generated and simulated in 3DEC (Figure 19). A visual comparison between the results of the DFN models and the previous deterministic models shows a similar type of failure mechanism with planar failure on the Floors and lateral release provided by the Grain and Shortahs. This highlights the detrimental effect of Floors on the stability of the model, particularly within the north-east part of the quarry. Figure 20 compares the block shapes and sizes in the stochastic models (Figure 19) and the initial deterministic model (Figure 12c). While the failed blocks within the deterministic model are formed by tetrahedral and pentahedral wedges (ranging in size from 4 to 8 meters), shapes of the failed blocks within the stochastic models vary from tetrahedral and pentahedral wedges to polyhedral and columnar blocks (ranging in size from

1 to 10 meters). This provides an improved indication of the in-situ variability of block shapes and sizes observed in the north-east slope of the quarry. Similar to the deterministic models, the majority of the failed blocks are located within the northern and north-eastern parts of the quarry slope. In order to better understand the stability of each DFN realization, using the same methodology as in section 6.2.1 (Figure 13e), displacements throughout the models are recorded and presented using a colour coding approach (Figure 21). The displacement plot of realization 3 shows failure of only one history point while realizations 1, 2 and 4 show failure of several history points. It should be noted that due to the relatively large distances between the history points, some of the block failures (in between history points) may not be recorded by the history points. Realization 4 shows the highest displacement value (5.2 meters) within the four realizations.

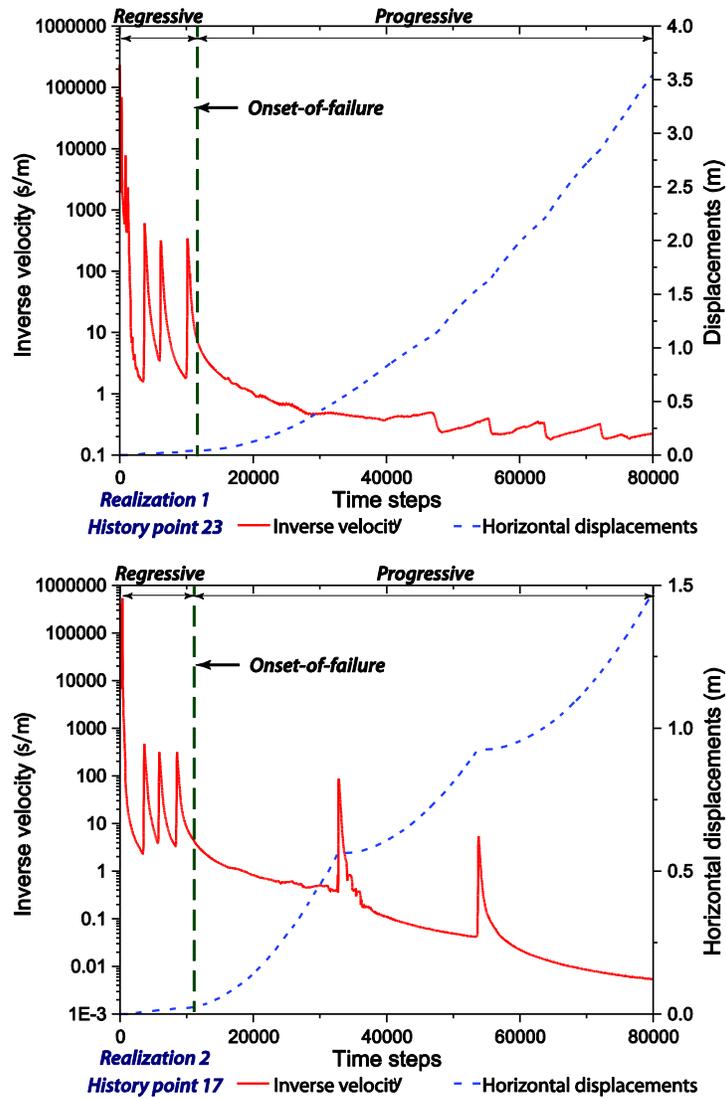
Figure 22. Superimposed plots of inverse velocity, horizontal displacement and onset of slope failure for realization 1 and 2

Depending on the kinematics and relative orientation of discontinuities that surround a failing block, different failure behaviour may occur. In order to further our understanding on the failure mechanism of the failed blocks, inverse numerical velocity and horizontal displacement plotted against time steps can be used. This “inverse velocity” method is often used in displacement monitoring practices to predict the time of failure. Using this method the stability of a moving slope is assessed by defining if monitored velocity data indicates that the slope movement is regressive or progressive (Zavodni and Broadbent 1980; Mercer 2006; Dick et al. 2013). A regressive movement is periodic deceleration of the slope leading to a stable slope while a progressive movement displays accelerating displacements leading to slope collapse. In this method, the point at which the behaviour of the slope changes from regressive to progressive is called “onset-of-failure”. Figure 22 compares inverse numerical velocity plots for realization 1 (history point 23) and realization 2 (history point 17). The onset-of-failure in the 3DEC model coincides with the point at which the inverse velocity plot starts approaching zero and subsequent displacements continuously increase. Although the onset-of-failure for both models occurs at 10000 calculation time steps, the progressive part of the two plots exhibit two distinct behaviours. The horizontal displacement plot of realization 1 exhibits a relatively smooth increase and the inverse velocity plot shows a relatively smooth decrease towards zero indicating the complete kinematic freedom of the failing block. In realization 2 however, the downward trend of inverse velocity and

upward trend of horizontal displacement are interrupted in two instances (time steps 32800 and 53800). This indicates a relative degree of block confinement and interlocking in the vicinity of the failing block prohibiting continuous displacement of the block. Figure 23 explains the clear differences in the failure mechanism and inverse velocity plots of the failing blocks in realizations 1 and 2. Due to their kinematic freedom, the failing blocks in realization 1 are continuously moving out of the slope while the movements of the failing blocks in realization 2 are slowed and constrained by confinement and interlocking caused by displacements of the neighbouring blocks. This inter-relation between slope failure, kinematics and inverse velocity plots has been previously observed in numerical simulation of natural and engineered slopes using Slope Model (Itasca 2010), a 3D brittle fracture code (Havaej et al. 2014 and Havaej et al. Submitted).

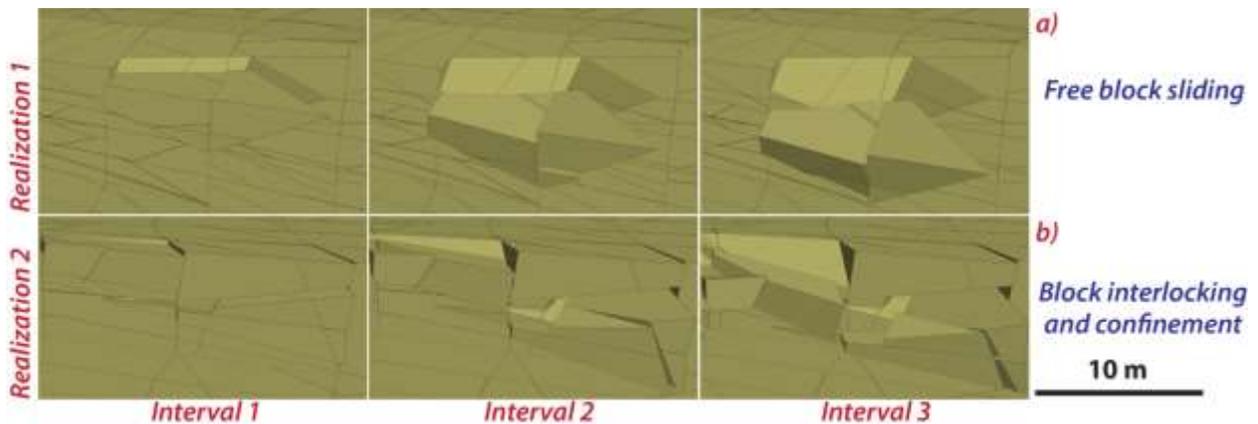
Figure 23. Insets comparing free sliding of the failing blocks in realization 1 with interlocking and confinement of the failing blocks in realization 2
