1 **Application of an integrated geotechnical and topographic monitoring system in the Lorano**
2 **marble quarry (Apuan Alps, Italy)**

19 **Abstract**

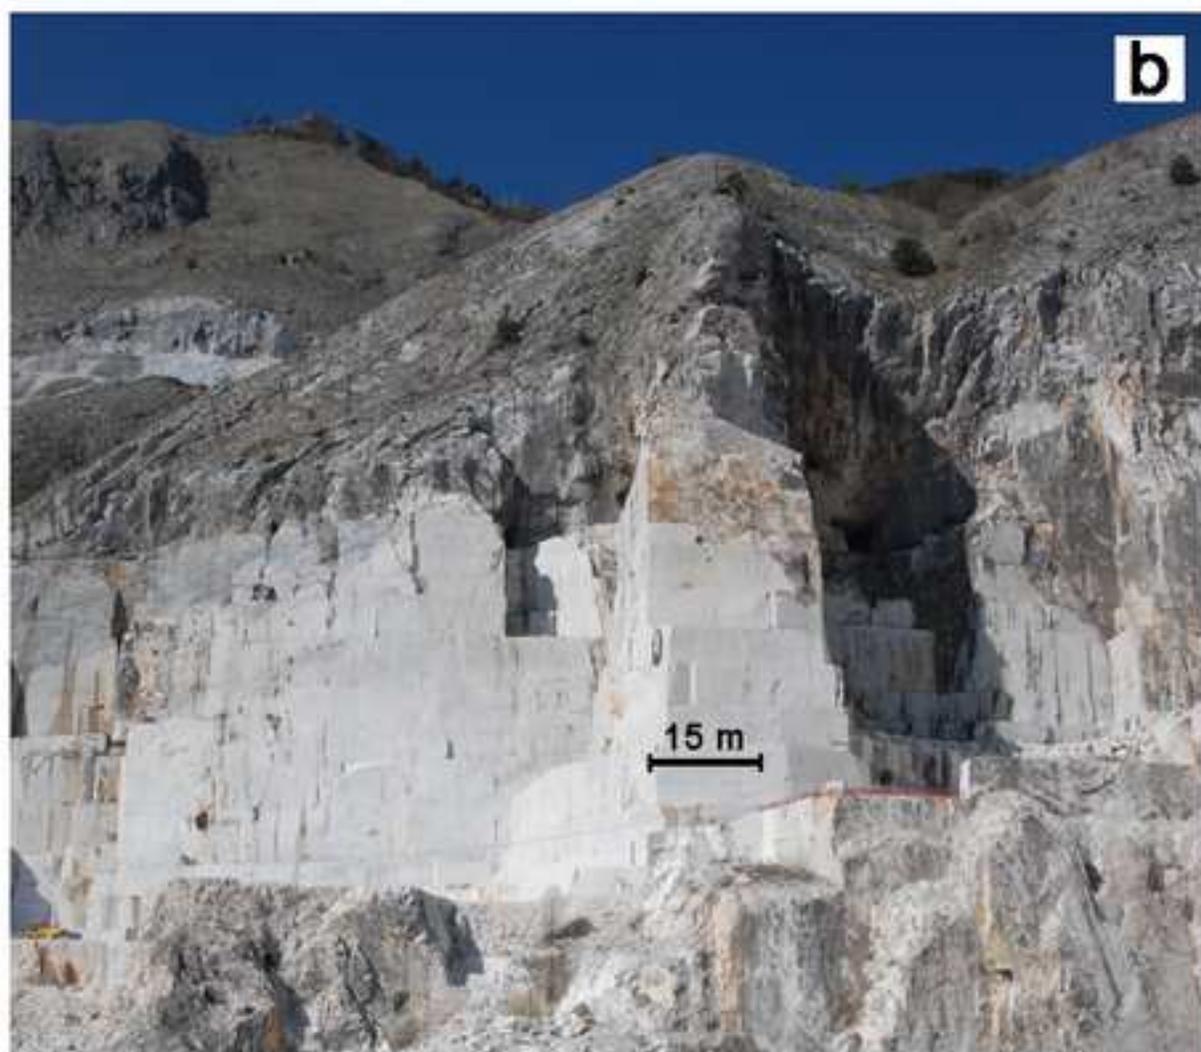
Figure 1 (Color) - single-column
[Click here to download high resolution image](#)

625 Fig. 1. Study area. a) Topography of the site. Black circle indicates the marble buttress; inset map shows the location of
626 the study area (modified from Salvini et al., 2014a). b) Panoramic picture of the quarry with the buttress under study in
627 the foreground.

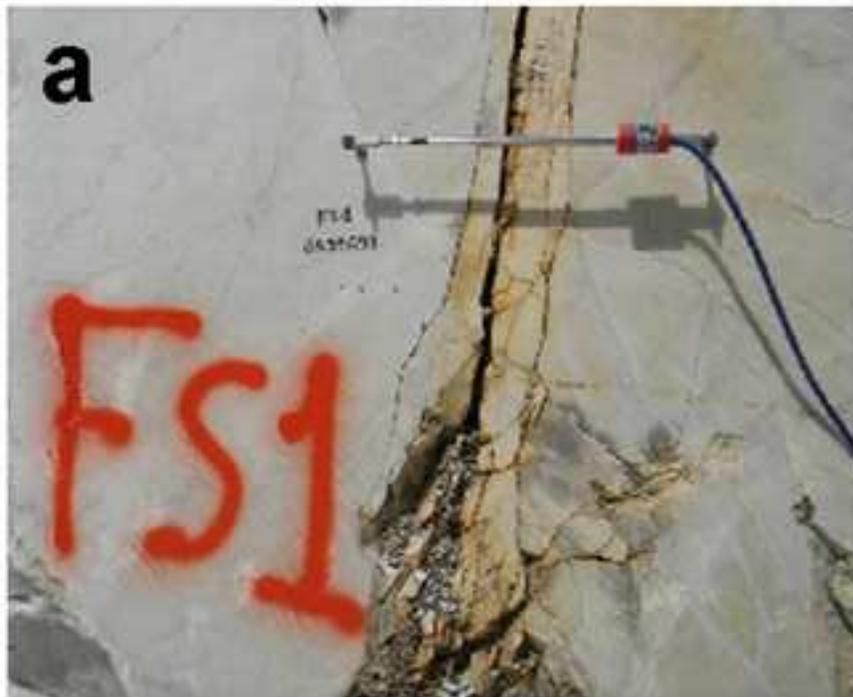
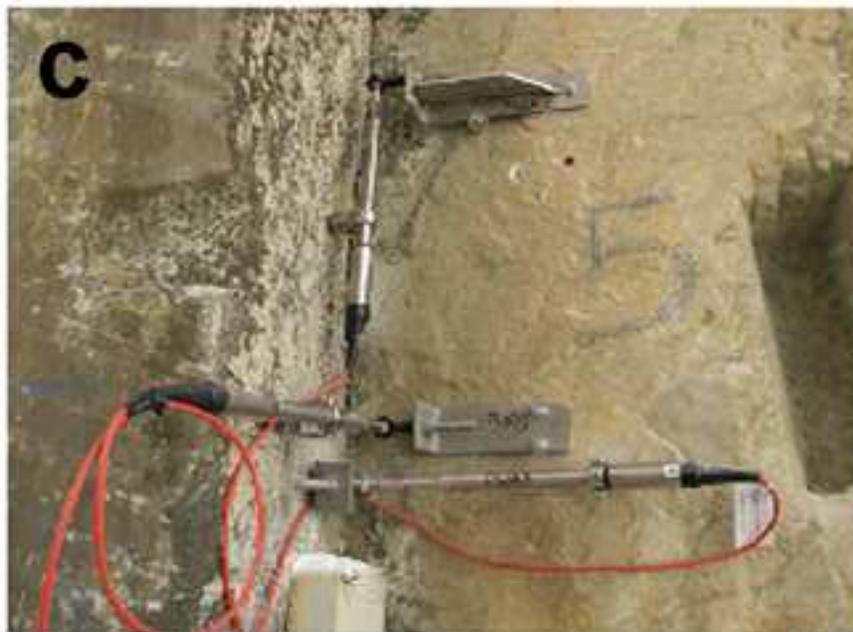
Figure 3 (Color) - single-column
[Click here to download high resolution image](#)

632 Fig. 3. Examples of geotechnical sensors installed on the buttress. a) Monoaxial mechanical crackmeter. b) Biaxial
633 clinometers. c) Three-directional crackmeter. d) Multipoint borehole extensometer (modified from Profeti, 2013).

163 The geotechnical monitoring system was the first installed on the buttress and it has been run by
164 “*Cooperativa Cavatori Lorano*” and USL1 of Massa and Carrara. It consists of four multipoint
165 borehole extensometers (three bases, the deepest of which is placed at a depth of 30 m), 12
166 monoaxial mechanical crackmeters, one three-directional crackmeter, and two biaxial clinometers
167 (examples are shown in Fig. 3). The technical specifications of the sensors indicate that the
168 accuracy of monoaxial crackmeters and of extensometers measuring either up to 25 or 50 mm
169 range, is respectively 0.025 and 0.05 mm. The three-directional crackmeter can measure
170 displacements of up to 50 mm and has a resolution of 0.1 mm, with a specified precision better than
171 0.5% of full scale, corresponding to 0.25 mm. Clinometers have a resolution of 0.001% of the full
172 scale, with a declared precision better than $\pm 0.04^\circ$. The data are registered by an electronic control

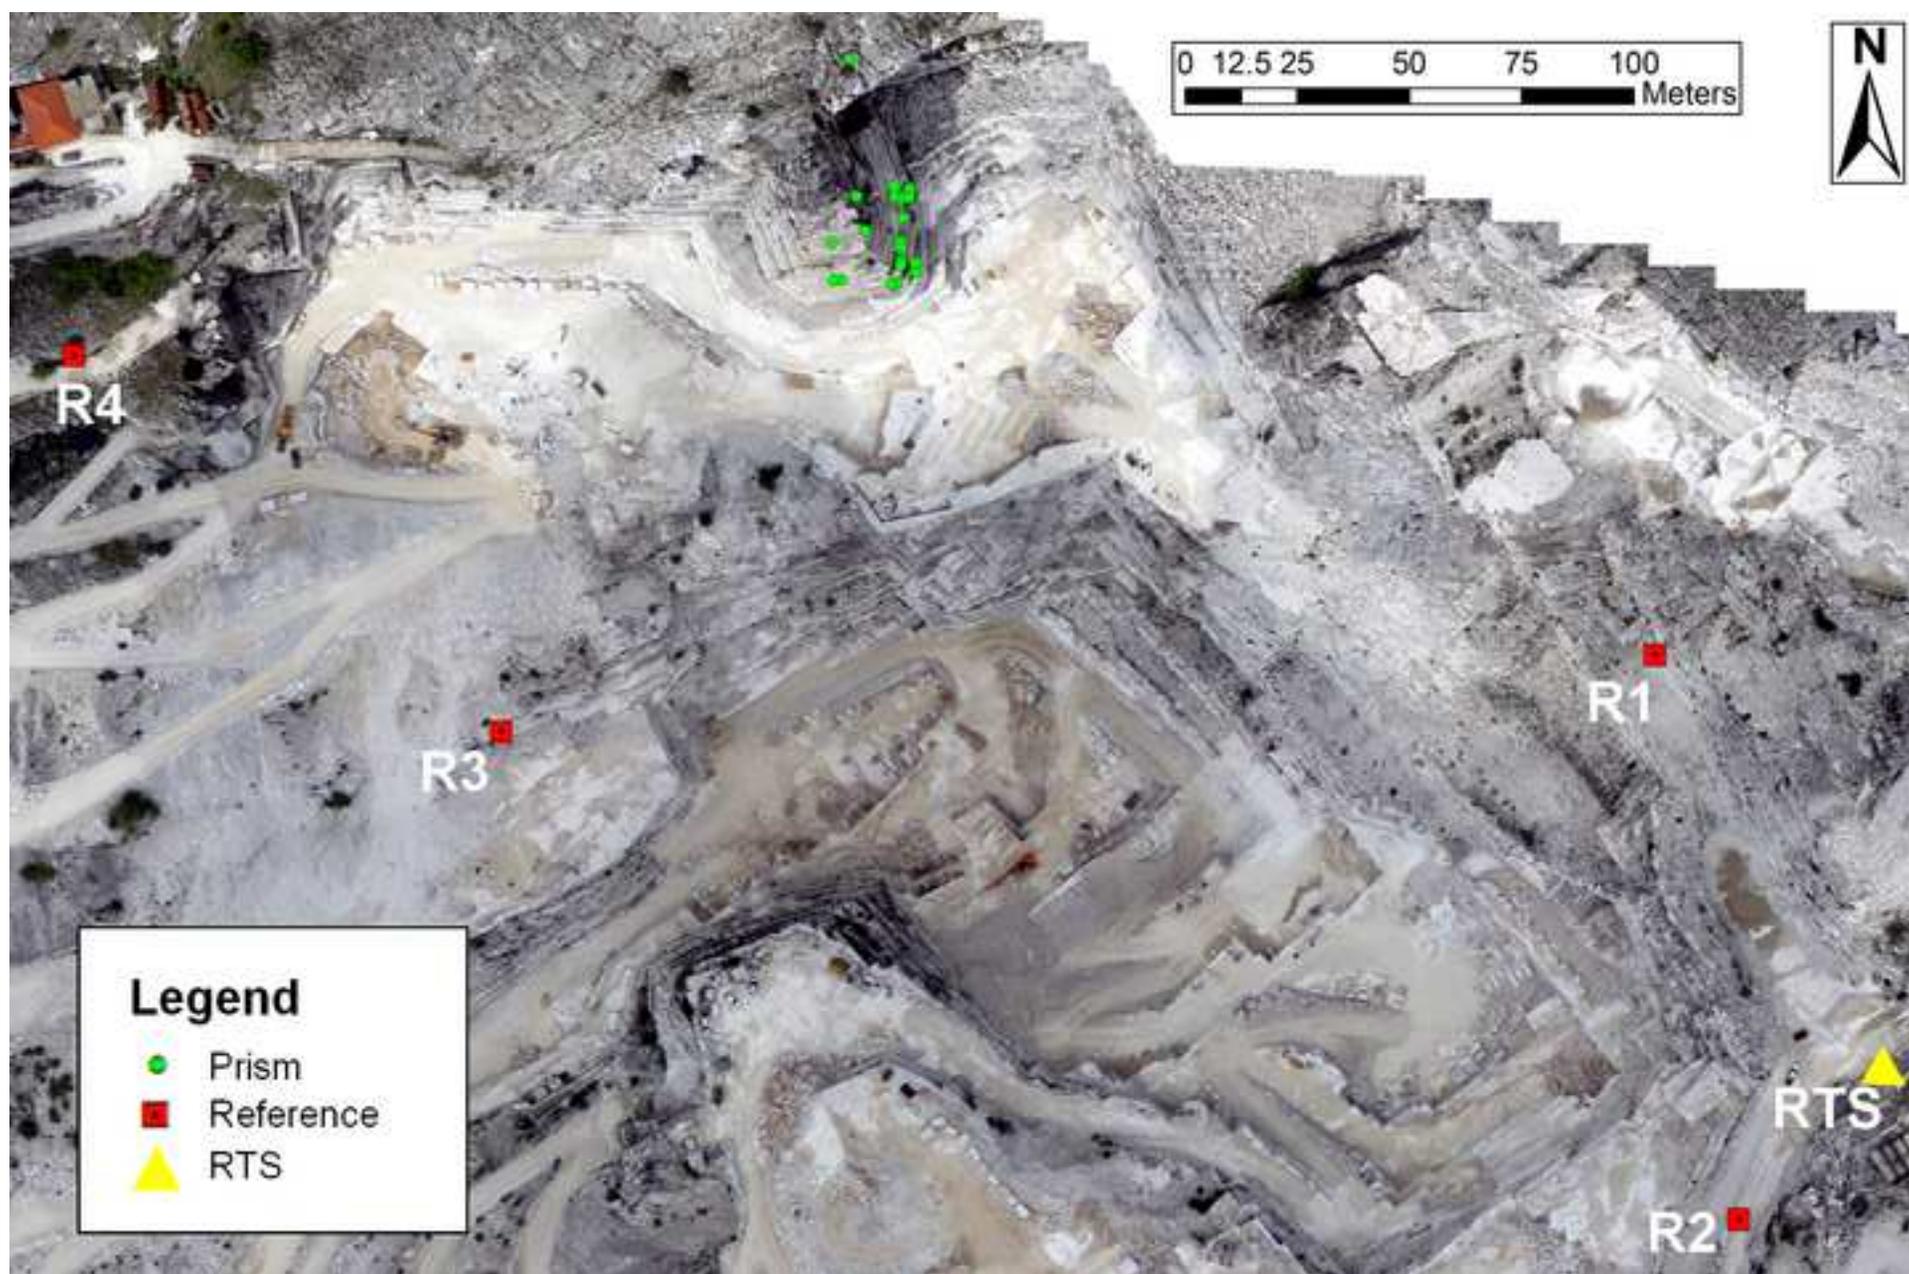
Figure 4 (Color) - 2-column
[Click here to download high resolution image](#)

635 Fig. 4. UAV orthophoto showing the location of prisms, reference points and the RTS.

200 The positioning of the prisms on the buttress took into account findings from the engineering
201 geological surveys and the location of the geotechnical sensors. The RTS is installed in an external
202 stable site (Fig. 4) and automatically takes measurements of 24 prisms fixed to the rock mass by spit
203 anchors. Twenty prisms were placed on the buttress (approximately 300 m from the RTS), most of
204 them located near the geotechnical instruments (Fig. 5), at the hanging wall and footwall of the

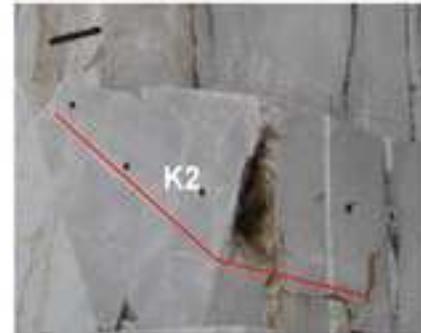
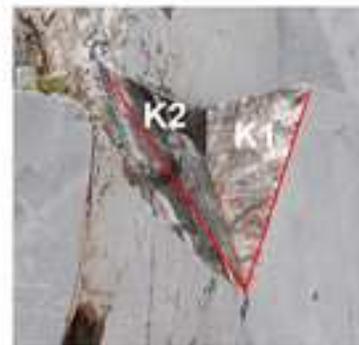
Figure 7 (Color) - 2-column
[Click here to download high resolution image](#)

262 A discontinuity friction angle of 35° was used in the analysis neglecting a cohesion contribution:
263 this agrees with data in the literature (Chang et al., 1996, Perazzelli et al., 2009) and previous
264 studies carried out by quarry’s advisors (Profeti and Cella, 2010). Table 2 shows the potential
265 failures identified through kinematic stability analysis (examples are shown in Fig. 7).

Kinematic Analysis	Planar Sliding
Slope Dip/Dip Direction	90/80
Friction Angle	35°
Lateral Limits	60°
	Critical Total %
Planar Sliding (All)	1 4 25

Kinematic Analysis	Wedge Sliding
Slope Dip/Dip Direction	90/80
Friction Angle	35°
	Critical Total %
Wedge Sliding	3 6 50

Kinematic Analysis	Direct Toppling
Slope Dip/Dip Direction	90/250
Friction Angle	35°
Lateral Limits	60°
	Critical Total %
Direct Toppling (Intersection)	1 6 16.6
Oblique Toppling (Intersection)	0 6 0
Base Plane (All)	2 4 50

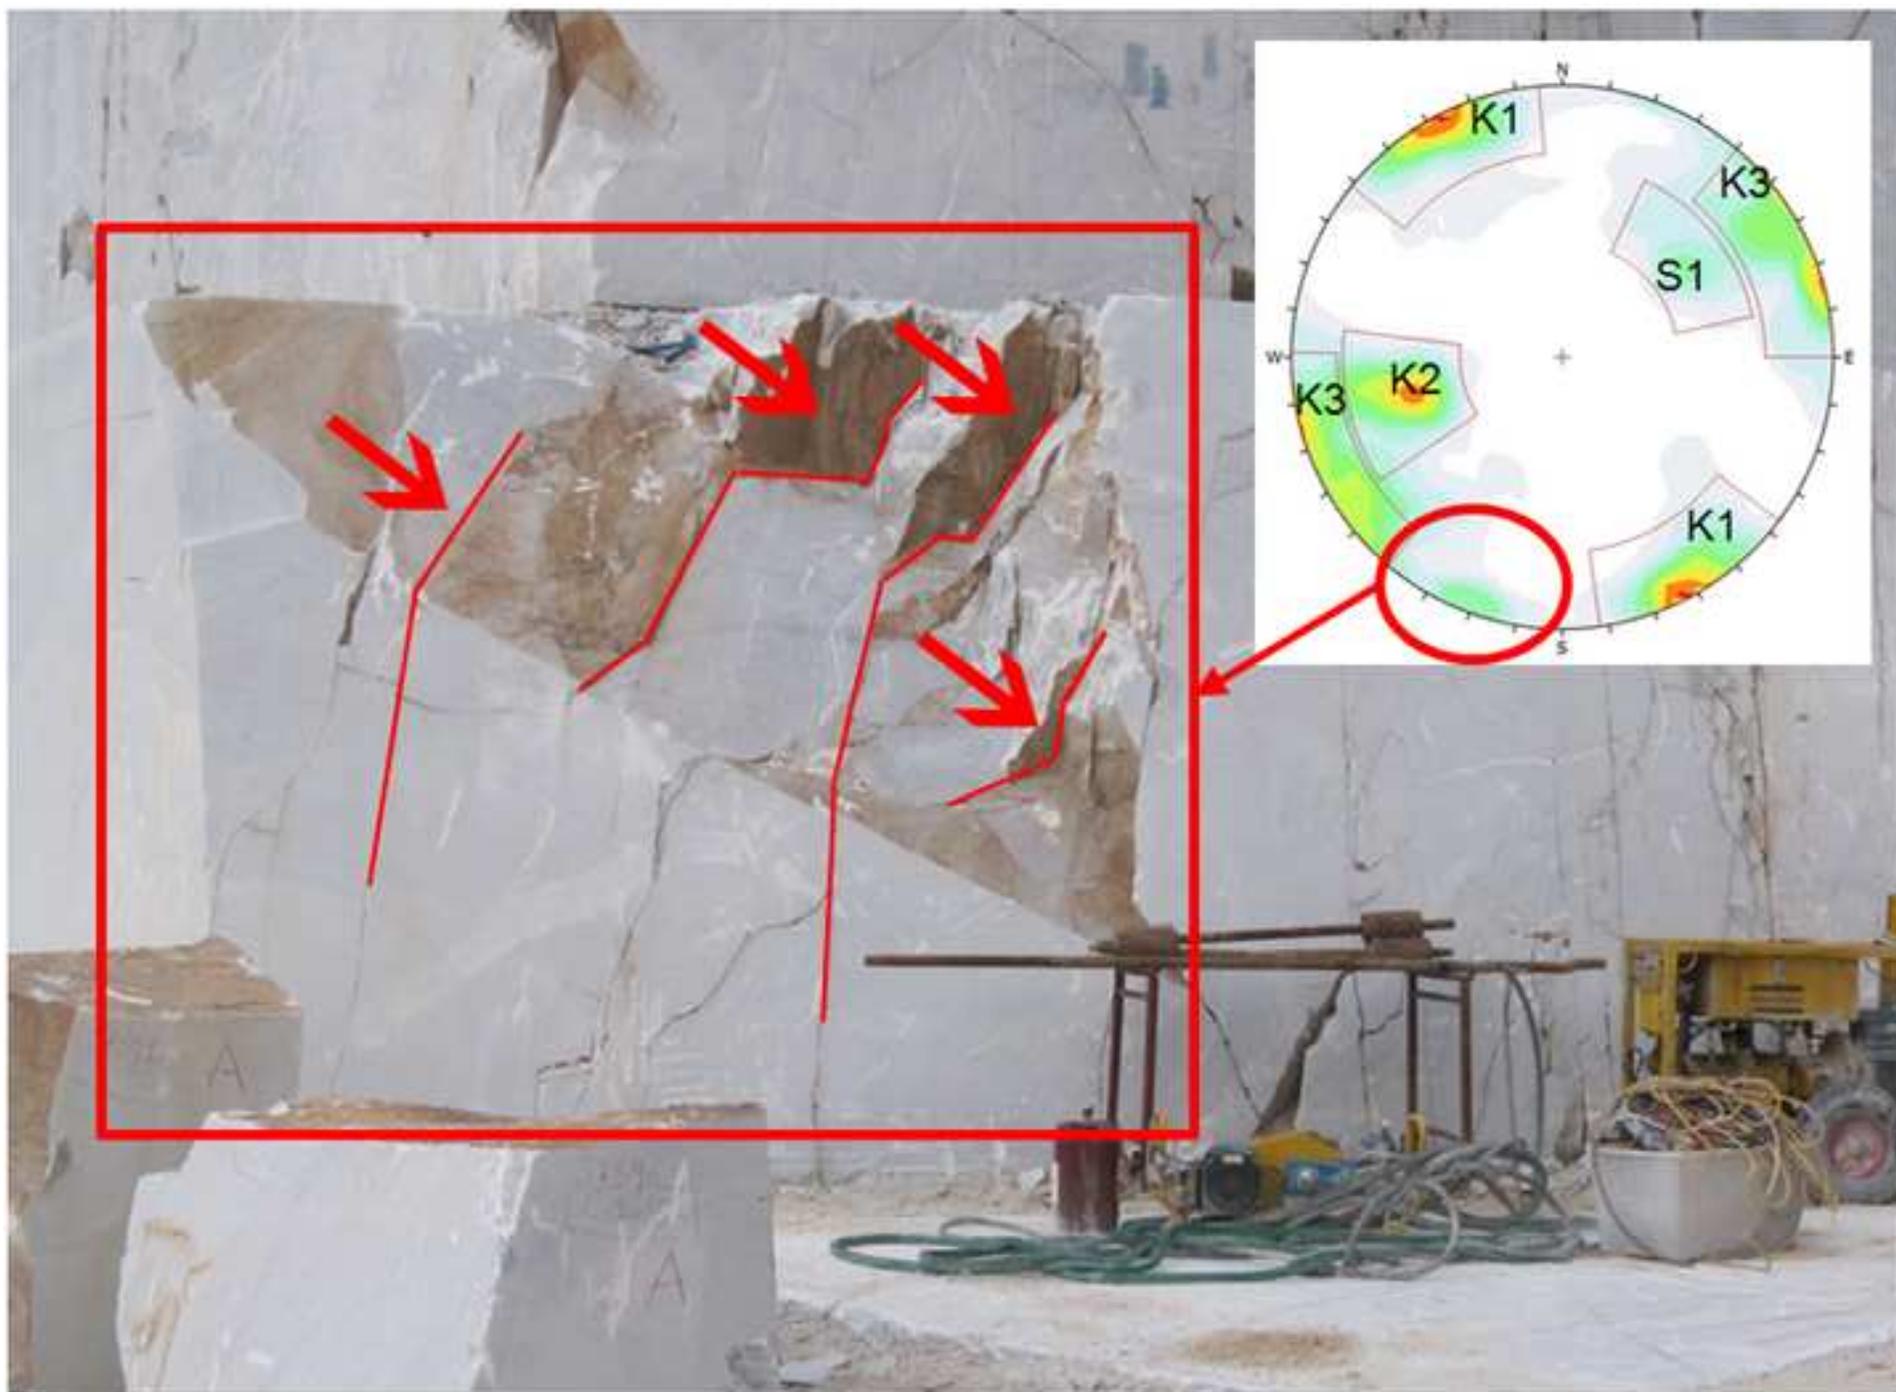
Figure 16 (Color) - single-column
[Click here to download high resolution image](#)

672 Fig. 16. Newly formed set of joints at the toe of the buttress.

389 would otherwise have been undetected without very deep borehole extensometers. The direction of
390 prism displacement both during the entire investigated period and after intense rainfalls, as well as
391 the presence of newly formed brittle fractures, suggests a tensional stress field with NE–SW
392 extension. These observations confirm the importance of integrating different monitoring systems to
393 provide indications at different spatial scales.
