1 **The use of an unmanned aerial vehicle for fracture mapping within a marble** 2 **quarry (Carrara, Italy): photogrammetry and discrete fracture network modelling**

8 **Abstract**

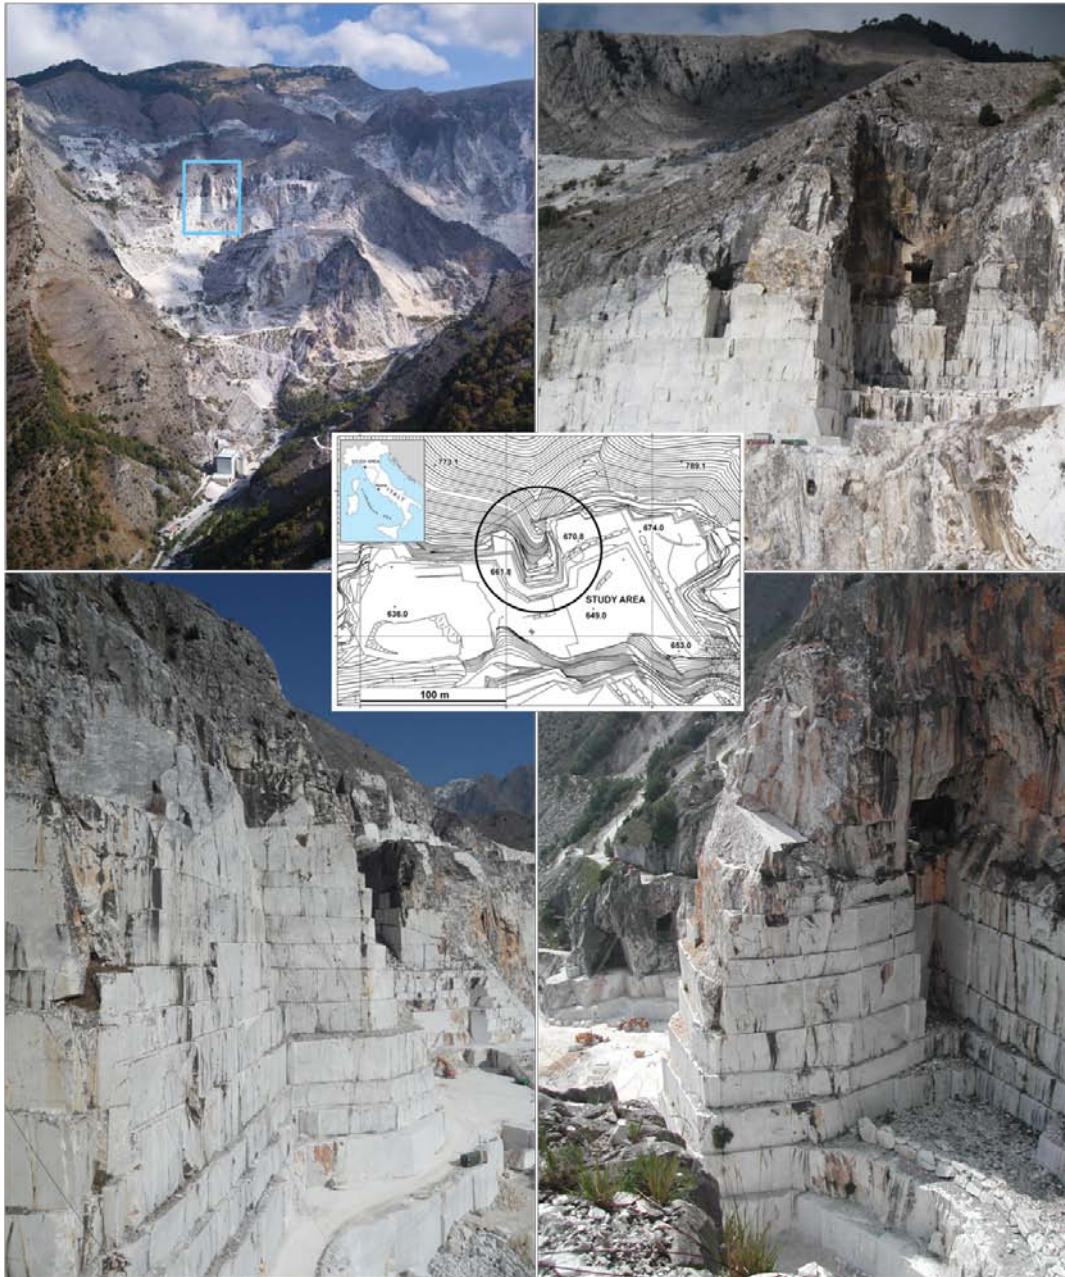
Figure 1: Study area. Topography of the site (in the centre, from Salvini et al., 2014); black circle indicates the marble buttness; inset map shows the location of the study area. Panoramic view of the quarry, with the investigated buttness highlighted by a rectangle (upper left); southern side of the buttness (upper right), western side of the buttness (lower left) and eastern side of the buttness (lower right).

92 The Lorano open pit is located in the Province of Massa and Carrara, northwestern
93 Tuscany (Italy). In 1997 a rockfall in the quarry interrupted excavation activities for a
94 few weeks. Remediation works were subsequently carried out with the aim of ensuring
95 safety, and a marble buttress accessible from three sides was emplaced (figure 1). Due
96 to the ongoing quarrying activity the buttress is now about 150 m high, 30 m wide and
97 40 m thick.

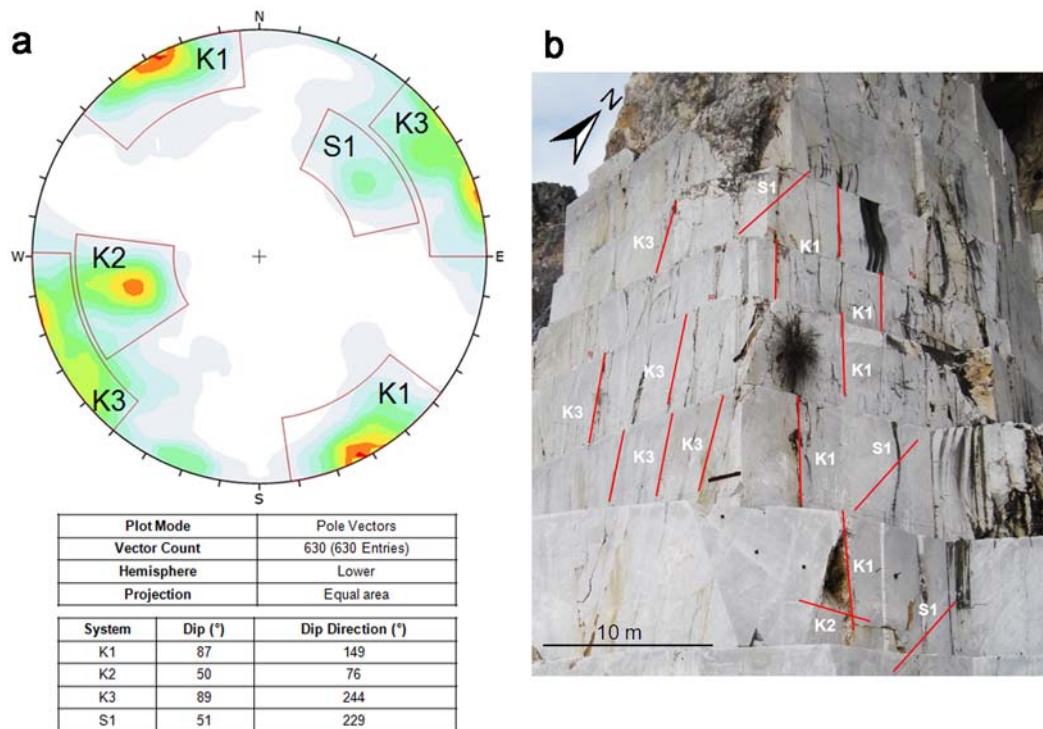
166 Figure 3: Joint systems. a) Pole plots and mean attitudes of joint systems from engineering geological,
 167 DTP and TLS surveys. Data are shown in stereographic projection using the Schmidt equal-area method.
 168 b) Examples of K1, K2, and K3 joint systems and S1 foliation in the buttress (from Salvini et al., 2015).

149 An engineering geological survey was carried out to characterise the geomechanical
150 properties of discontinuities. Data were collected in accessible areas using traditional
151 scan-line mapping techniques whereby all the discontinuities that intersect a defined
152 scan line are recorded. About 100 discontinuities longer than 10 m were identified in
153 seven scan lines. Collected data were compared with those of Profeti and Cella (2010)
154 for the same area and integrated with DTP and TLS data from inaccessible zones, as
155 described in Francioni et al. (2015). The attitude of 301 joints was calculated from TLS
156 and an additional 236 discontinuities were manually measured from the
157 photointerpretation of UAV imagery (Francioni et al. 2015). Data processing revealed
158 the following four sets of discontinuities (named K1, K2, K3 and S1 in accordance with
159 Profeti and Cella, 2010) describing the current state of the buttress (figure 3): S1

160 (foliation) - SW dipping with average dip of about 50°, corresponding to Sp of
161 Carmignani et al. (2002); K1 - SE dipping, subvertical, corresponding to J1 of
162 Carmignani et al. (2002); K2 - NE dipping with average dip of about 50°, corresponding
163 to J2 of Carmignani et al. (2002); and K3 - SW dipping, subvertical, corresponding to
164 J3 of Carmignani et al. (2002).

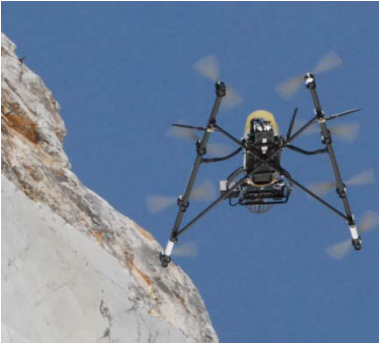
190 Table 1. UAV and camera specifications.

UAV Type	Dimensions	Engines	Rotor diameter	Empty weight	Max. take off weight
	V-Form Octocopter	770 x 820 x 125 mm	Brushless motors	8" (~ 20 cm)	1.1 kg	2.3 kg
	Camera	Sensor type	Sensor Size (mm)	Image size (pixel)	Pixel size (mm)	Focal length (mm)
Sony NEX-5	CMOS	23.4 x 15.6	4592 x 3056	0.004763	16.0121

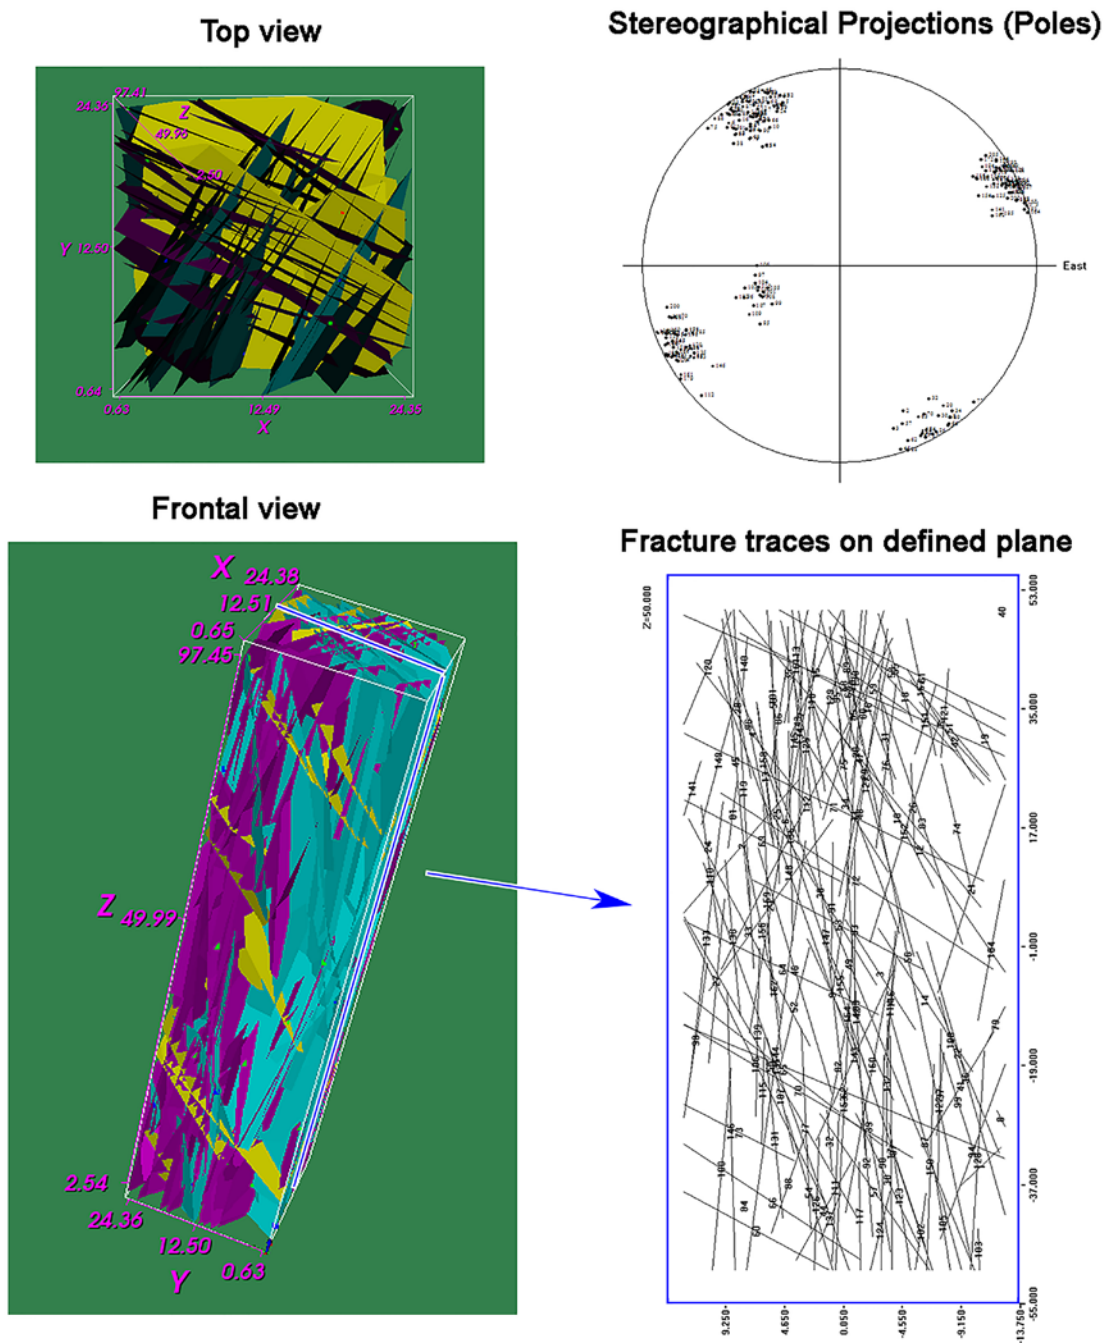
361 Figure 9. Generation of a DFN model for the marble buttress using FracSim3D. K1, K2 and K3 joint sets
 362 included.

363 The S1 foliation was not included in the shown model because it does not represent a
 364 real plane of discontinuity in the studied quarry. Nevertheless, it is a plane of weakness
 365 that could affect the stability of the buttress and will be the subject of future research.

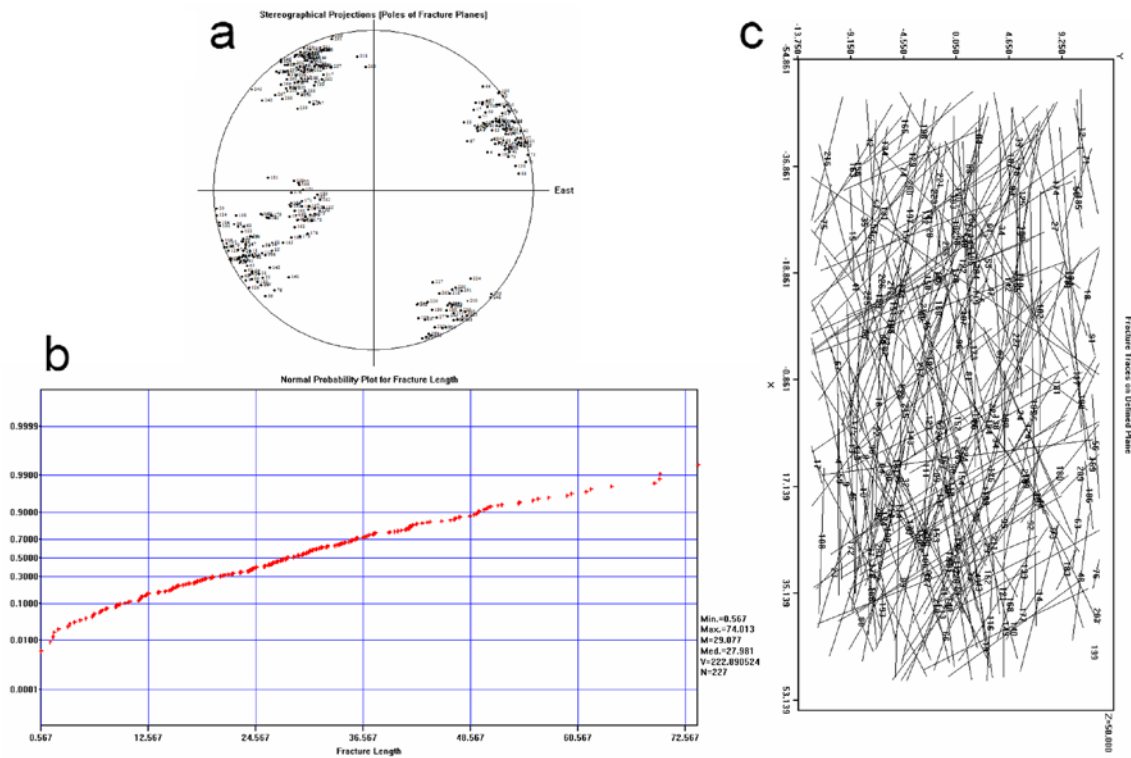
373
 374 Figure 10. Generation of a DFN model for the marble buttress using FracSim3D with P_{10} certain values.
 375 K1, K2 and K3 joint sets included. a) Stereonet, b) Normal probability plot for fracture lengths, c) 2D
 376 DFN model section.

370 2D representations (including stereonet and normal probability plots for fracture
 371 lengths) of two DFN models generated using respectively certain and certain+uncertain
 372 P_{10} values (as average among all the 6 mapped windows).

444 range from 10 m to 30 m for K1, K2 and K3. This work correlates well with these
445 findings, as illustrated in the two normal probability plots (figures 10b and 11b), which
446 show that the majority of the fracture traces have lengths between 10 and 35 meters.
