1 **A combined field/remote sensing approach for characterizing** 2 **landslide risk in coastal areas.**

9 **Abstract**

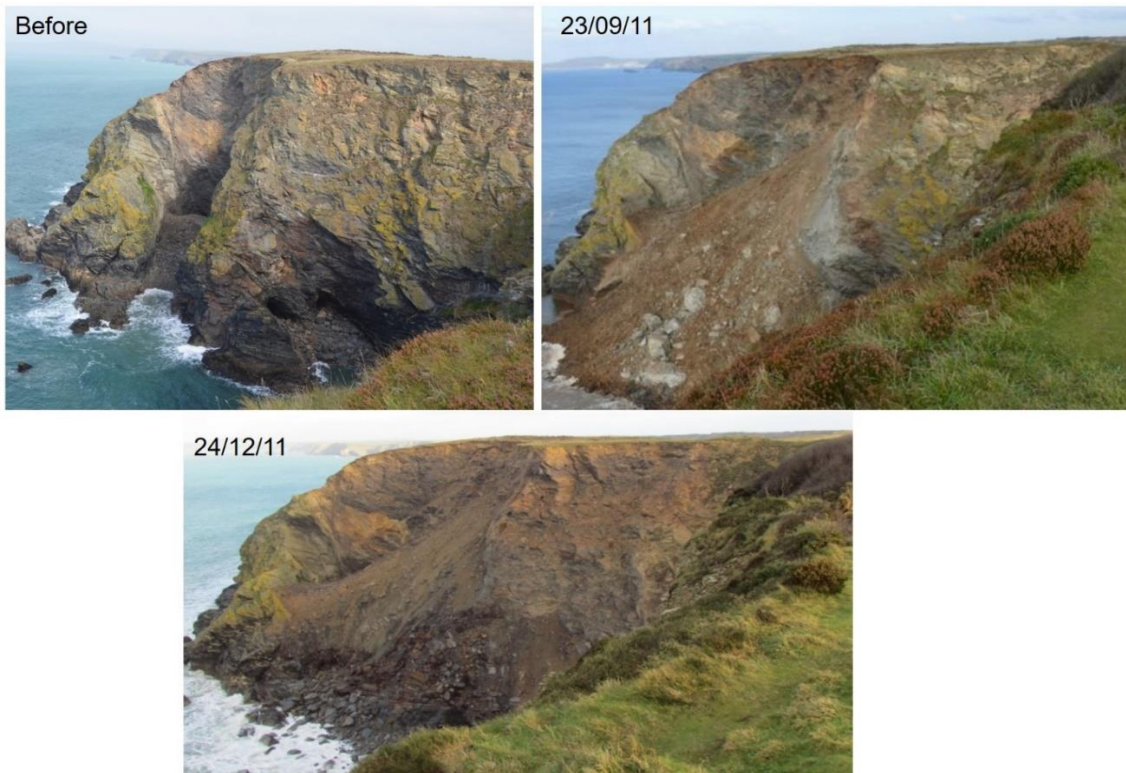
137 Figure 2 shows that the Hell's Mouth instability was associated with two major episodes of
138 instability. The initial failure captured on video was subsequently followed by later failure of
139 the section of the coastline immediately to the south of the original failure (cliff face dipping
140 towards the west).

142 Figure 2. Photographs of Hell's Mouth failure area prior to failure and two subsequent
143 episodes of instability. Comparison of photographs taken on 23/09/2011 and 24/12/2011
144 show further instability of the South-West section of the failure area a few weeks after the
145 main landslide that was captured on video (photograph taken looking towards SSE).

433 A study of photographs taken before and after the Hell's Mouth failure also show that this
 434 failure (Figure 2 and 6B) was influenced by F1 (listric faults with dip varying from 10° to

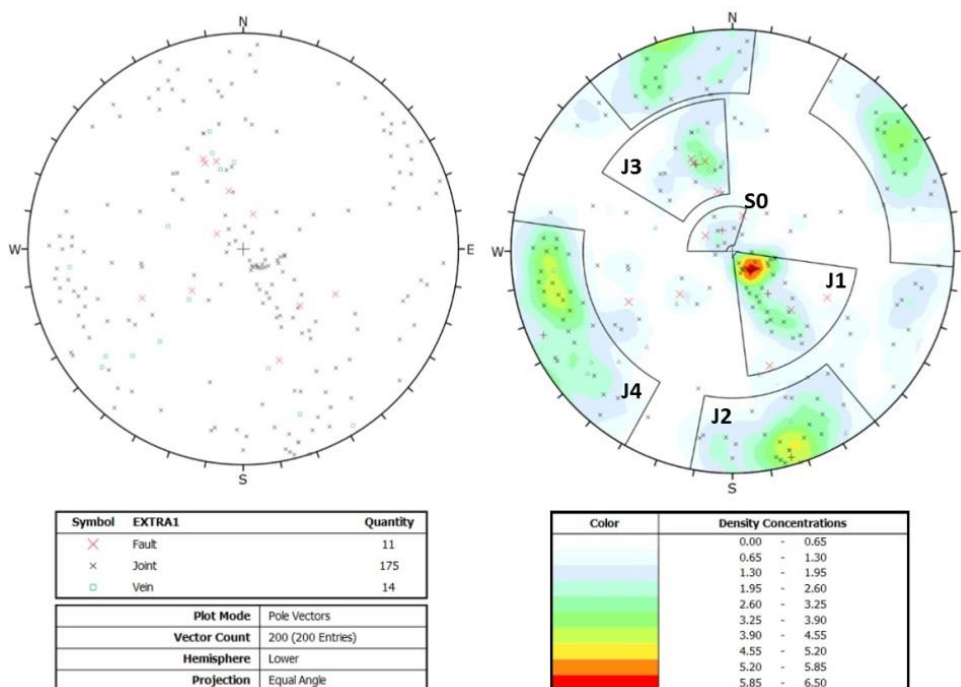
292 Figure 4. Stereonet representing 200 discontinuities collected during an engineering
 293 geological survey of a representative section of coastline within the study area.

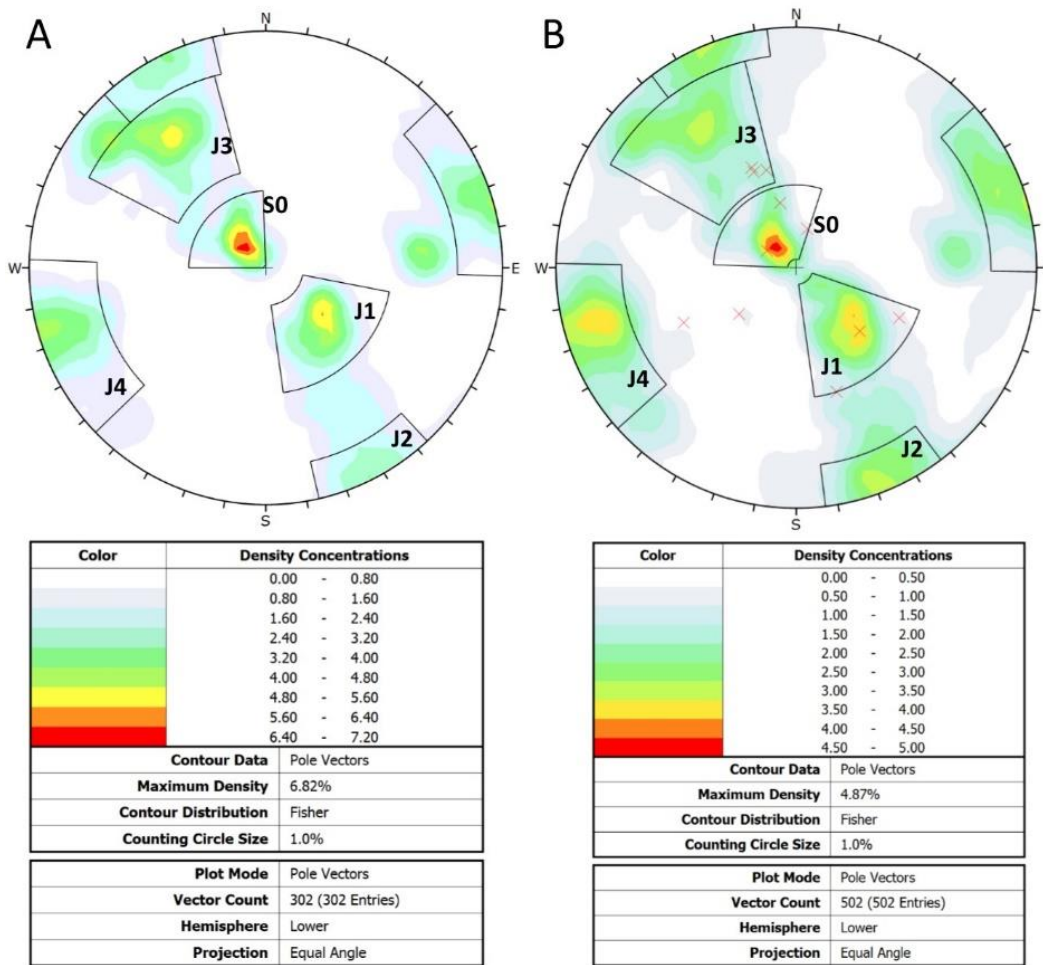
296 Figure 5. Lower hemisphere stereonet obtained from: A) the photogrammetric data, number
 297 of measurement equals 302; B) Combination of engineering geological mapping and
 298 photogrammetric data (number of measurement equals 502, red crosses highlight faults
 299 mapped during engineering geological survey).

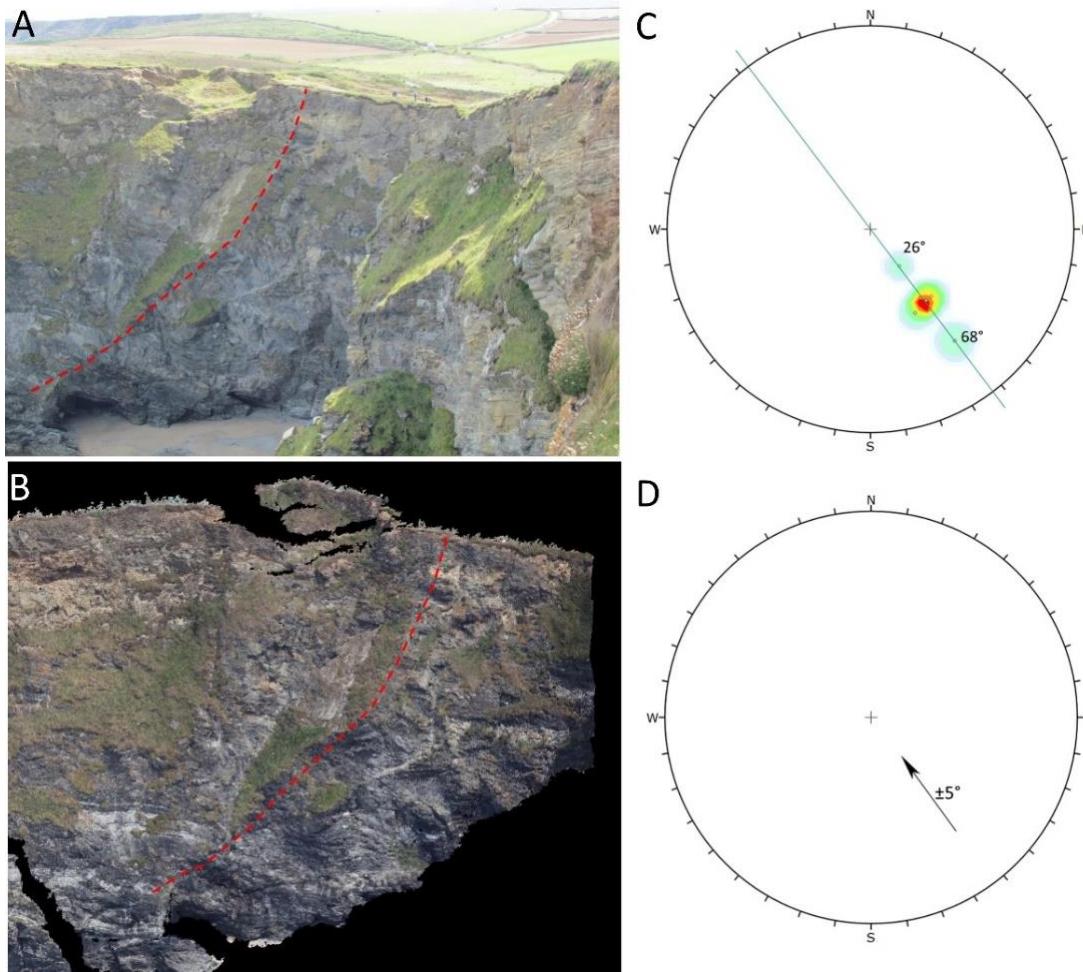
353 belonging to F1. Split-FX was used to take measurements from the orthorectified 3D model
354 along the fault surface (Figure 7B). This data was then transferred onto the lower hemisphere
355 stereonet (Figure 7C) and a best fit line/arrow drawn starting from the highest to lowest dip
356 values (Figure 7D). The arrow provides information about the fault dip direction (direction of
357 the arrow), the range of dip (from the beginning to the end of the arrow) and dip direction
358 variation related to the waviness of the fault surface. When plotted on a kinematic
359 stereographic analysis using a daylight envelope construction, it may then be possible to
360 recognize potential bi-planar/multi-planar fault controlled mechanisms.

363 Figure 7. A) Listric fault highlighted in photograph. B) Photogrammetric 3D model of the
 364 area. C) Stereonet of five measurements of the listric fault surface measured in the 3D model,
 365 26° and 68° are the lowest and highest dips measured along the fault. D) Proposed
 366 representation of a listric fault on the stereonet; 5° represents the dip direction variability
 367 measured in the 3D model.

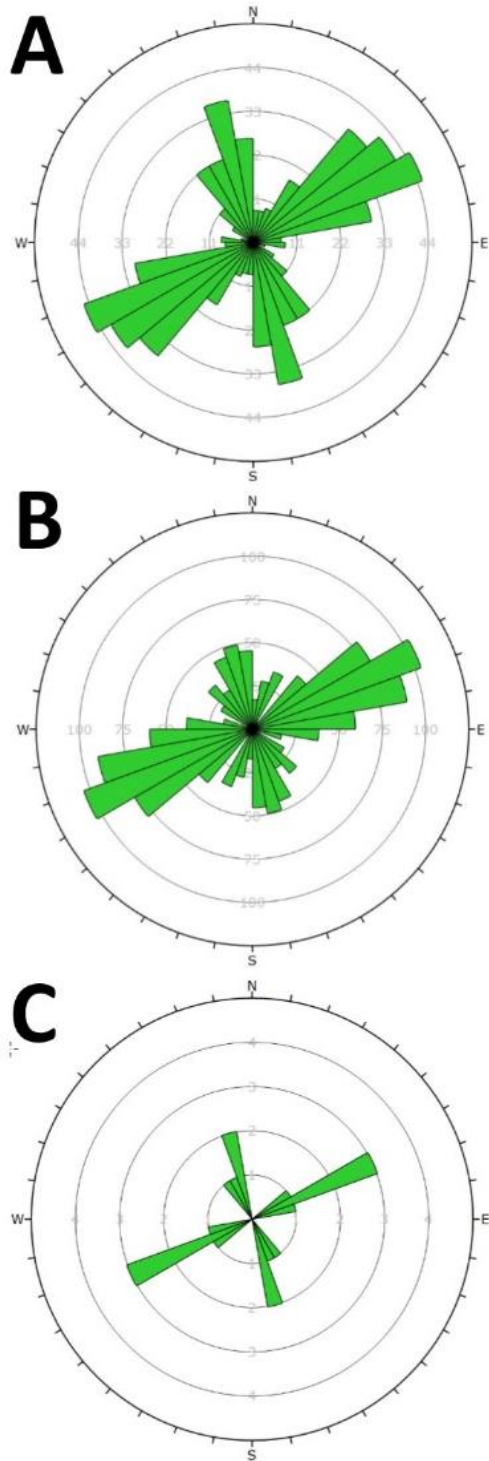
422
 423 The tension cracks behind the failure scar were mapped both in the field and using the
 424 available ortho-photos and their azimuth plotted on a rosette diagram. These features are
 425 associated with the same trends as identified in the GIS analysis. Figure 12 shows the
 426 measurements related to the major lineament, coastline and tension crack orientations plotted
 427 on a rosette diagram (Figure 12A-C).

429 Figure 12. Rosette plots of major trends observed in structural/lineament data from the study
 430 area. A) Trends observed in discontinuity orientation data from engineering geology and
 431 remote sensing surveys. B) Coastline aspect analysis. C) Tension crack orientation analysis.

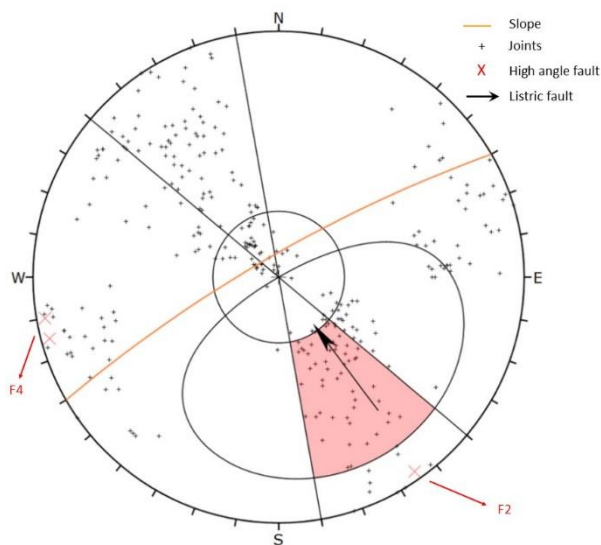
443
 444 Figure 13. Kinematic analysis of the Hell's Mouth failure

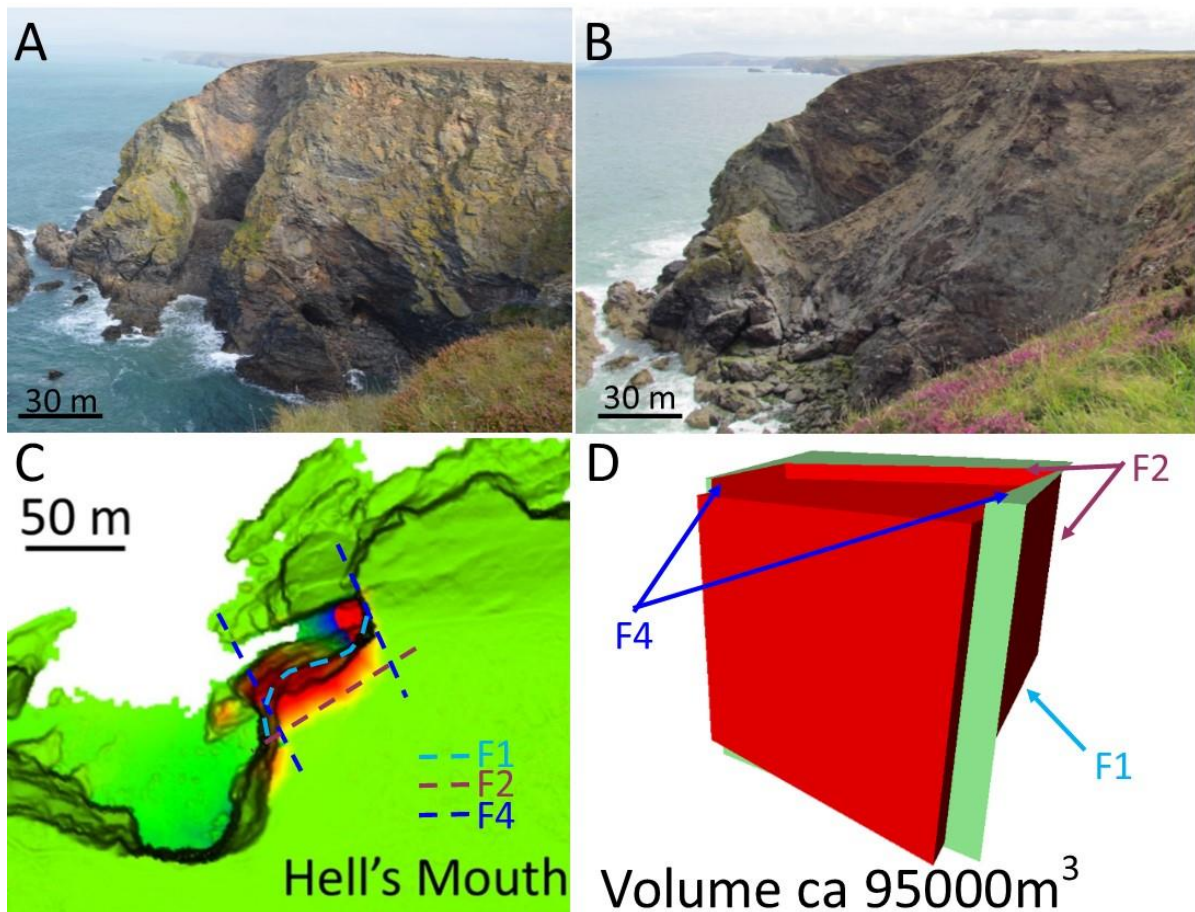
445
 446 Given the current tension crack growth, both in width and length, behind the failure scar there
 447 is an increased likelihood of further instability. Figure 14 provides a reconstruction of the
 448 Hell's Mouth failure: Figures 14A and 14B show the Hell's Mouth slope before and after the
 449 failure; Figure 14C shows the comparison of 2011 and 2014 LiDAR data of the Hell's Mouth
 450 failure highlighting the role of the structural geology and, finally, Figure 14D provides a
 451 conceptual 3D model of the failure using the Rocscience SWedge software (Rocscience,
 452 2016). It should be noted SWedge does not allow modelling of listric (a surface with varying
 453 dip) faults and for this reason, F1 is shown in this simplified representation as a planar
 454 surface combining with F2 to form a biplanar wedge.

456
 457 Figure 14. Hell's Mouth failure. A) Hell's Mouth slope before the failure (Photograph taken
 458 looking towards North-East). B) Hell's Mouth slope after the failure (Photograph taken
 459 looking towards North-East). C) Comparison of 2011 and 2014 LiDAR data and structural
 460 features. D) Conceptual 3D model of the failure (View looking towards South-East).

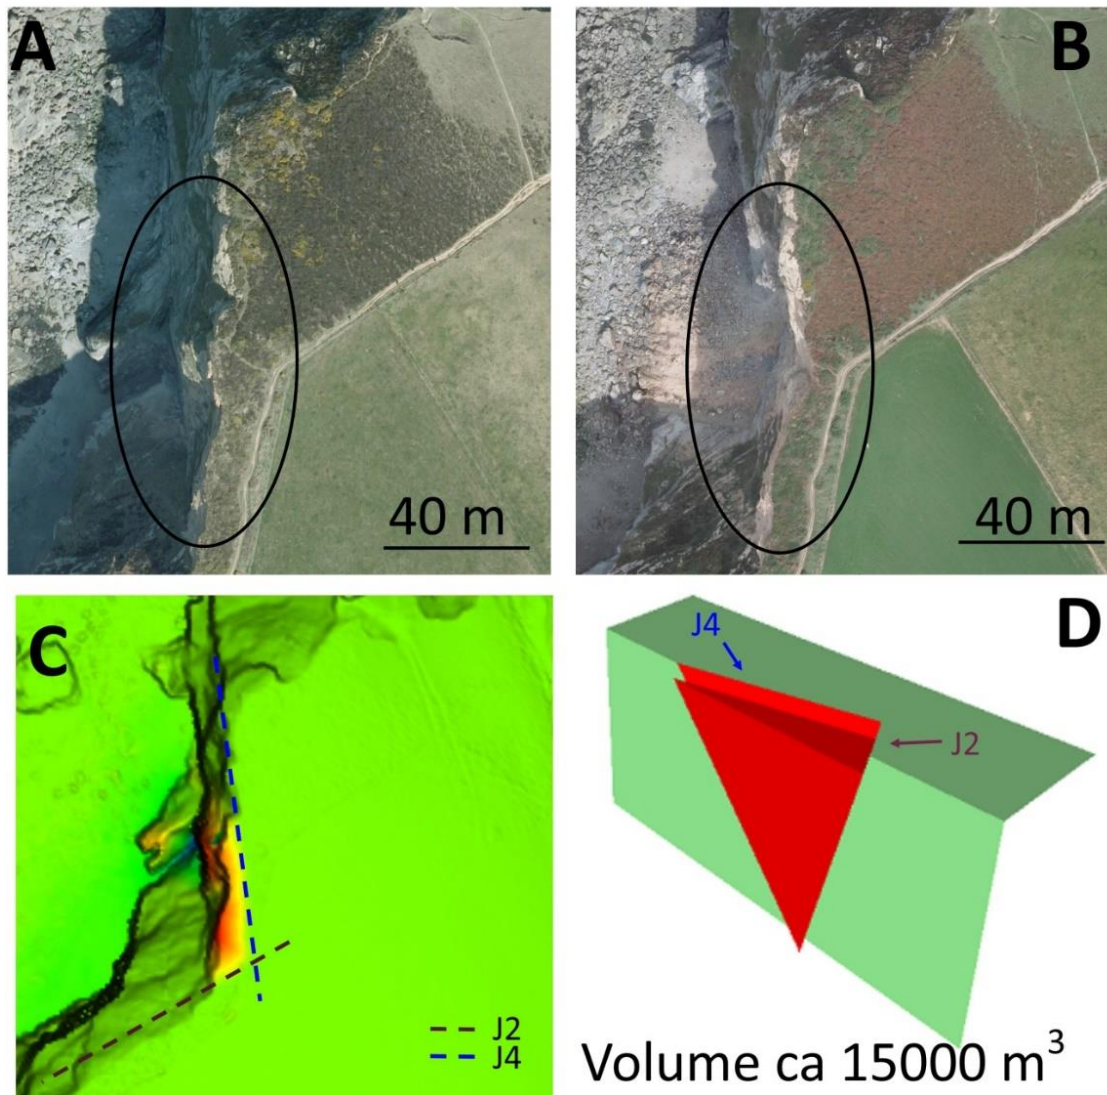
461
 462 Regarding the minor failure detected by the LiDAR comparison at Basset's Cove (Figure 10),
 463 it can be seen in Figure 15 that this wedge failure occurred along F2/J2 and F4/J4. Figures
 464 15A and B show the ortho-photographs before and after the failure. Figure 15C shows the
 465 2011 and 2014 LiDAR comparison and, finally, Figure 15D shows a conceptual 3D failure
 466 model. The volume of this failure, ca 15000 m³ (calculated with SWedge software), is much
 467 smaller than the failure that occurred at Hell's Mouth (ca. 95000 m³). In this case listric faults
 468 (F1 and F3) do not daylight in the slope (dipping toward W) and the failures are associated
 469 with high angle failure surfaces F2 and F4 (without the interaction with lower angle dipping
 470 sets) that generate smaller failure volumes. This conceptual model is a simplified
 471 representation of the failure that may also have involved a series of smaller wedges/blocks or

473 purposes, 2.5D volume computations of the respective failures were undertaken in
474 CloudCompare from the 2011 and 2014 LiDAR data. The calculated volume of the failure at
475 Hell's Mouth was found to be approximately 75126 m³ and Bassett's Cove 9850m³.

476
477 Figure 15. Bassett's Cove failure. A) Bassett's Cove slope before the failure. B) Bassett's Cove
478 slope after the failure. C) Comparison of 2011 and 2014 LiDAR data and structural features.
479 D) Simplified conceptual 3D model of the Bassett's Cove failure (View towards North-East).

523 (shown in Figures 18 and 20). Due to health and safety reasons, access to Basset's Cove area
524 (Figure 15 and bottom right image in Figure 18) was restricted and therefore the authors
525 performed structural analysis utilizing the aerial LiDAR dataset for validation (Figure 15).
526 How it is possible to observe in Figure 20 and as previously discussed, type and scale of
527 failure vary in relation to the structural control.

635 18 and 20) both pure wedge failures, related to the interaction between F4 and F1, and more
636 complex wedge failure generated by a series of smaller wedges/blocks or retrogressive
637 failures associated with intersections between F2/J2 and F4/J4 (e.g. Basset's Cove failure,
638 Figures 15 and 18) were observed.

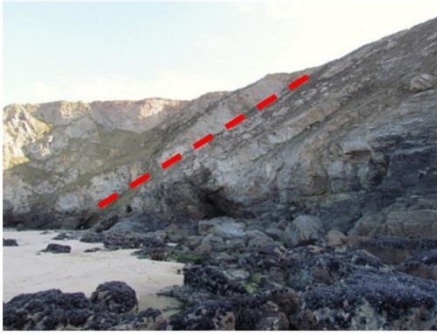
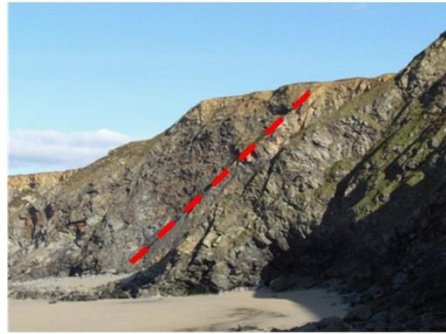
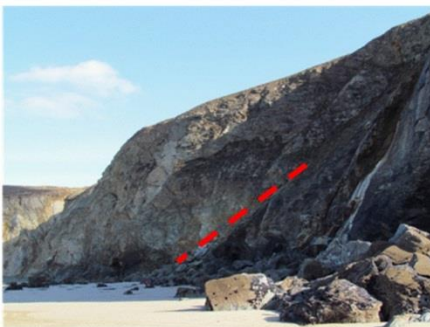
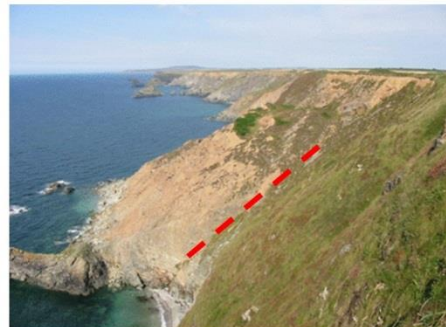
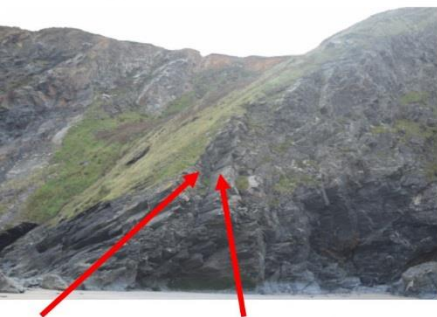
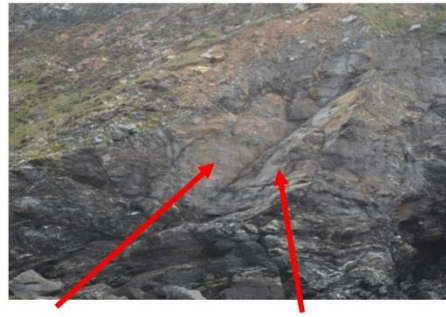
Planar Failure

F1: 40°/325°

F1: 45°/345°

F1: 35°/335°

F1: 45°/340°

Wedge Failure

F4: 85°/055° F1/2: 60°/340°

F4: 87°/060° F1: 30°/320°

535 Figure 20. Orientation of discontinuities controlling both planar and wedge failure for
536 selected photographs from Figures 17 and 18.

625 simplistic representation of the Hell's Mouth failure. It can be seen in the video of the
626 collapse, that the failure is more complex. The fracturing of rock bridges and the interaction
627 of highly persistent slope dipping faults (F1) with other fault systems (F2 and F4) and with
628 smaller less persistent joint sets could also contribute to failure. Further analysis with
629 numerical methods and analysis of additional data from UAV surveys will be carried out in
630 future to explore the complexity of the observed failure. These observations regarding
631 potential complex mechanisms can be extended to other large planar failures shown in
632 Figures 17 and 20, where failures occur along F1 with F2/J2 and F4/J4 act as tension cracks
633 and lateral release surfaces respectively. The planar failures could be also defined as wedge
634 failures, with F1 acting as the basal plane. With regards to wedge analysis (shown in Figures
