# Vibration monitoring and condition assessment of the University of Sheffield Arts Tower during retrofit

**University of Sheffield Arts Tower history, structural details and upgrade**

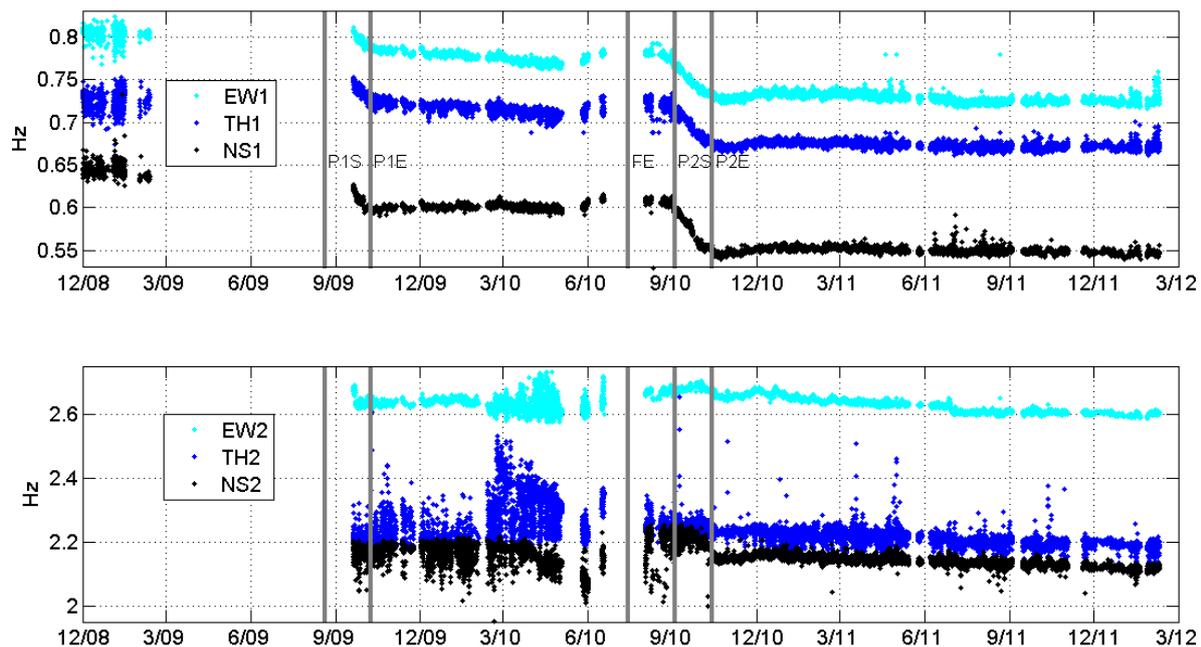
**Figure 7: Frequency variation in sway modes.**

The most remarkable feature demonstrated from the monitored frequencies in Figure 7 is the two periods during which the frequencies of the first three horizontal vibration modes (NS1, θ1, EW1) dropped rapidly. These correspond to the two distinct phases of partition removal.

Phase 1 removal of masonry partitions (levels 9 to 19) began in late July 2009 (before monitoring was operational) and was completed on 9 October 2009. This corresponds to the first period of steadily decreasing frequencies.

Phase 2 removal of masonry partitions (levels 8 down to level 1) began in the first week of September 2010, with one week per floor. This period corresponds to the fastest and most significant drop in frequencies visible in Figure 7.

**P1S and P1E mark start/end of Phase 1 partition removal, FE marks end of removal and replacement of facades, P2S, P2E mark start/end of Phase 2 partition removal.**

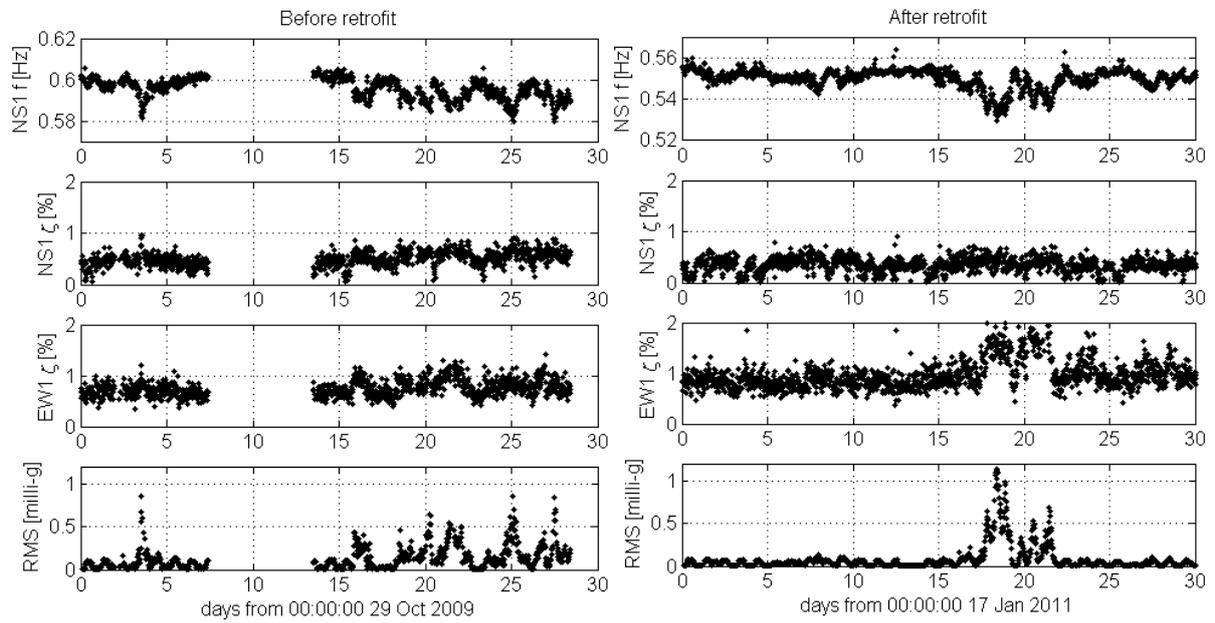
**Figure 8: Modal properties and response levels before and after Phase 2.**

Figure 8 zooms in on one month periods before and after Phase 2 showing variation in NS1 frequency, of NS1 and EW1 damping and of 30-minute RMS acceleration, for vector sum of broadband E and N components from a single a roof level accelerometer. In both cases maximum 30-minute RMS response exceeded 1 milli-g (9.81 mm/sec$^2$), which corresponds to 0.5mm for a frequency of 0.7Hz. Instantaneous values, estimated by double integration of acceleration data, reached 5mm, larger than (1.2mm) single mode amplitudes generated by BRE shakers.

NS1 frequency shows approximately 0.02Hz reduction per milli-g of response, EW1 similar, but the damping variation is more interesting. Before Phase 2 EW1 and NS1 show similar ranges consistent with the BRE results and modest increase with stronger response. After Phase 2 NS1 damping range has dropped while EW1 shows very clear dependence on amplitude. Histograms for the full durations of FSDL monitoring before and after Phase 2 are shown in Figure 9, clarifying the changes.

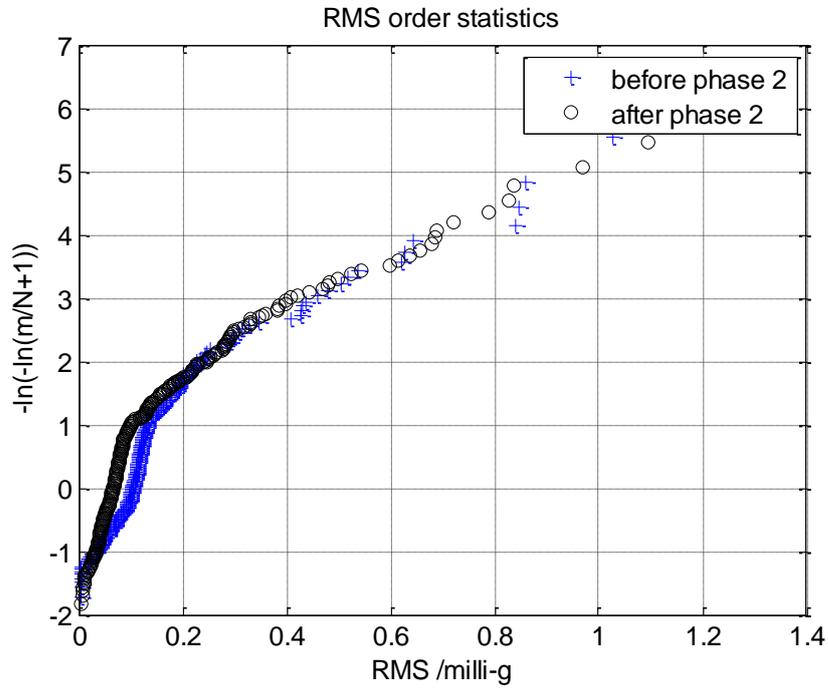
**Figure 10: Gumbel plot of rank (m) of daily maximum RMS values before and after Phase 2.**

With reduced frequency –implying reduced stiffness and altered damping ranges, what is the impact on response levels? There are too few reliable data points from processed 30-minute records to demonstrate convincing correlations, so the alternative approach of extreme value statistics is applied. The daily RMS maxima are obtained and their rank plotted as 'reduced variates' against corresponding response level as a Gumbel plot in Figure 10. While the maxima do not follow a linear trend (which would indicate a Gumbel distribution), the distributions are remarkable similar strongly suggesting that Phase 2 alterations had no significant effect on response levels.

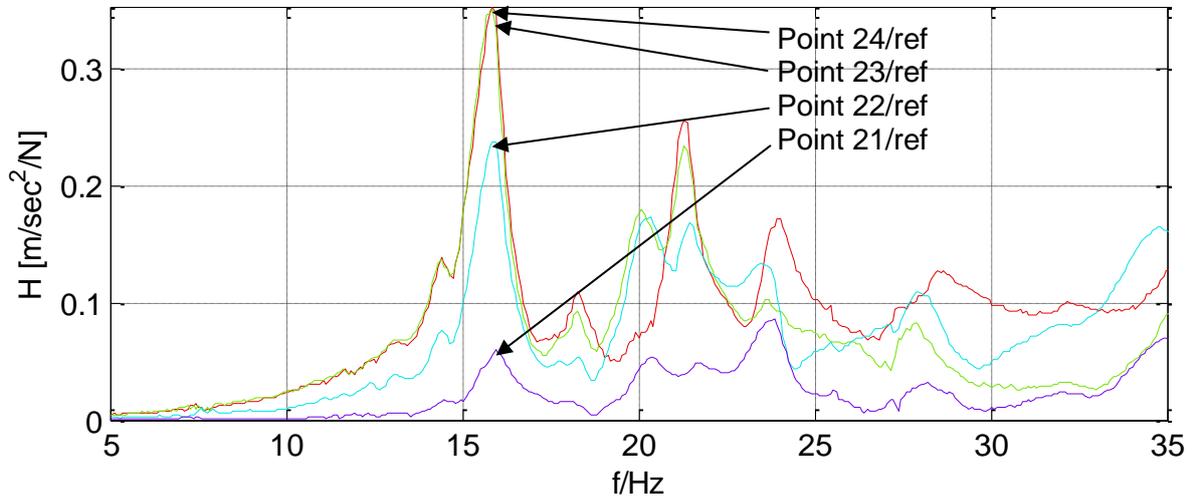
First the peaks for (cleared) L15_2009 are much sharper than those of L8_2009, which shows a lower damping, and the strongest FRF below 20Hz is 50% stronger for the cleared floor. Hence the partitions have provided additional damping.

Second the first two clear frequencies for L15_2009 are shifted down compared to L8_2009, the obvious conclusion being that the partitions provide considerable stiffness but relatively little mass.

**Figure 12 L8_2009: Un-cleared level 8 points 21-24. Note three modes up to 16Hz.**

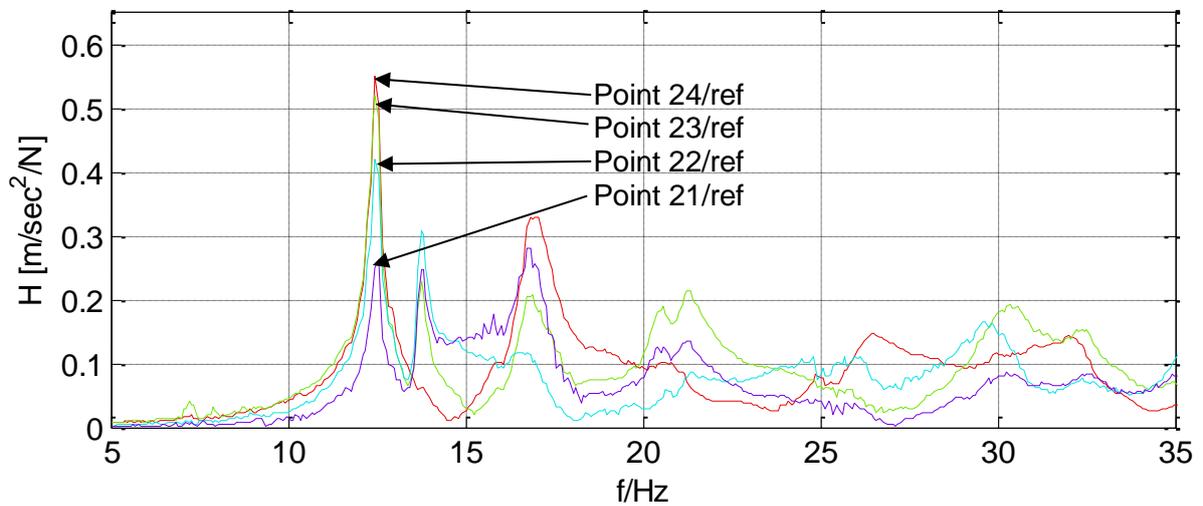
**Figure 13: L15_2009: cleared level 15 points 21-24; ref point is closes to points 21 and 22**

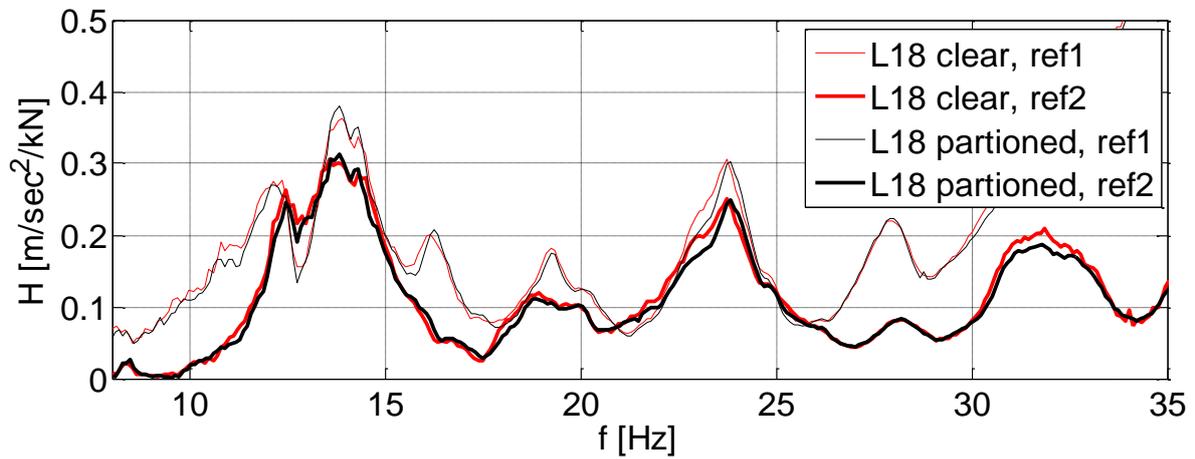
From the level 18 measurements, the effects of the movable partitions could be observed. Figure 15 shows point mobility FRFs (i=j=22,26) for two locations with and without partitions engaged over the remaining half of the floor above level 18. The engagement is effected by forcing out a set of locking pins to push up and down but there is negligible effect on the FRFs; for both locations the FRFs overlay perfectly with or without partitions extended.

**Figure 15: L18_2011: Point 22 and 26 driving point mobility FRFs with or without extended partitions.**

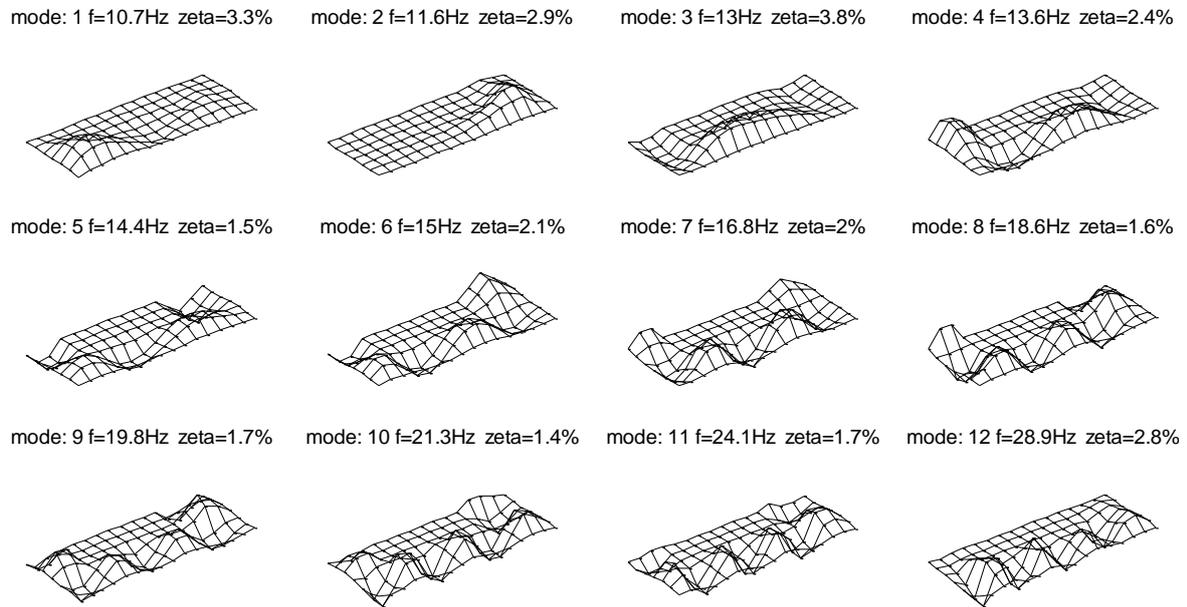
**Figure 16: Mode shapes for L8_2011 i.e. level 8 after retrofit.**

Mode shapes estimated for the comprehensive post-retrofit level 8 measurements are shown in Figure 16. The first three modes follow an expected pattern of global deformation with increasing order along the bay and all except the first mode are clearly visible in the FRFs of Figure 14. There is no second order mode in the short direction (across the wide bay) below 30Hz.

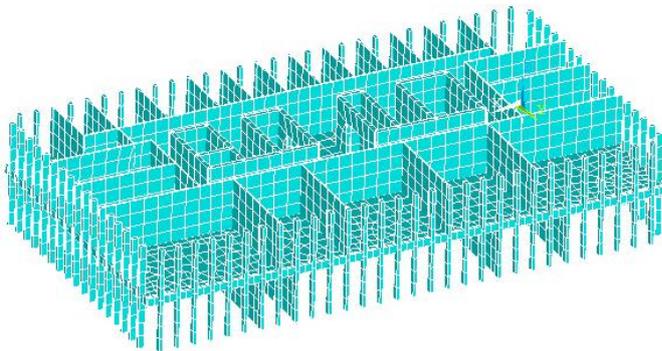
**Figure 18: Finite element model for floor vibration at level 8.**

The effect of 'non-structural' partitions is more graphically illustrated for floor vertical vibration modes where the reference case is Model 4 representing level 8. Figure 18 shows the model with par-titions; in all variants (with and without partitions) columns and core are fixed one level above and be-low.

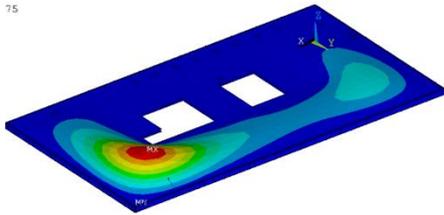
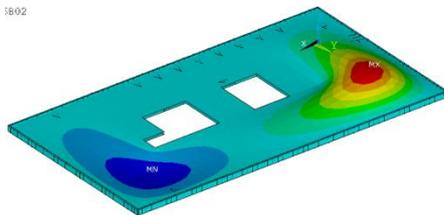
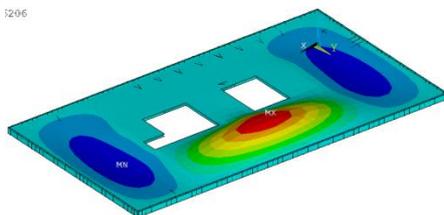
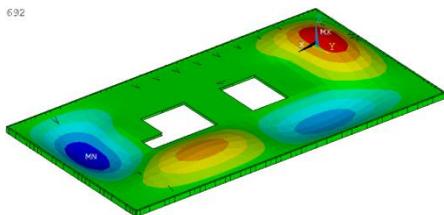
**Figure 19: Matching of Model 4 (without partitions) with L8_2011 measured modes. FEM modes on left, experimental modes on right.d**

Figure 19 compares Model 4 with no partitions with L8_2011 floor mode shapes. The agreement is acceptable; except for the first mode, the model underestimates the frequencies by an average 6%. The first two modes observed in L8_2011 measurements (10.7Hz and 11.5Hz) are relatively weak in Figure 14 as they involve motion of the slab at the ends of the long bays with little motion in the area of the shaker. Higher modes are stronger and the agreement is more convincing. This all points to Model 4 being able to represent the behavior of the bare slab reasonably, hence providing a good ba-sis for studying the effect of partitions.

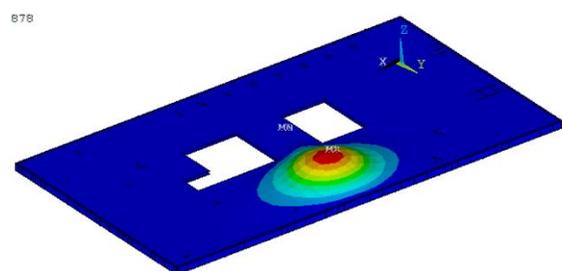
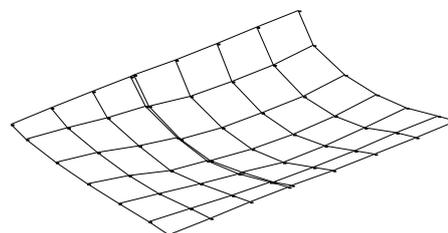
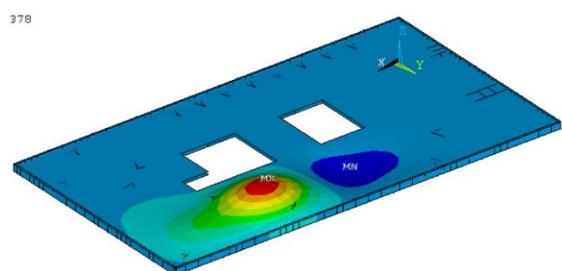
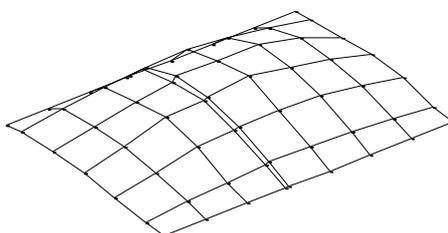
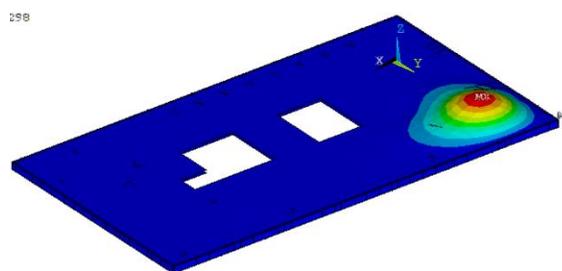
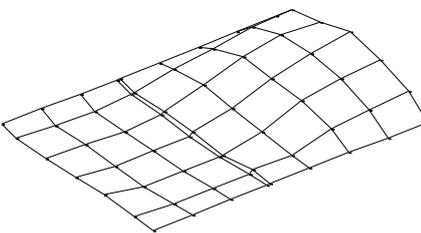
**Figure 20: Matching of Model 4 (with partitions) with L8_2009 measured modes.**

For comparison with L8_2009 measurements, partitions with low Young's modulus were included in Model 4. As for the sway behavior, using 3GPa resulted in overestimated mode frequencies, so comparison is given for the 1GPa variant in Figure 20. The significant difference from Figure 19 is that the modes are localized, fortunately in the area where L8_2009 measurements were made, with no sign of the progression of modes long the long bay shown for L8_2011 measurements of Figure 19.
