Abrasion process between a fibre mooring line and a corroded steel element during the transit and commissioning of a Marine Renewable Energy device

This paper brings together two experiences from TTI (Tension Technology International) and the UoE (University of Exeter) and aims to quantify the damage that could be experienced by fibre mooring lines during the transit and commissioning phase of Marine Renewable Energy (MRE) devices.

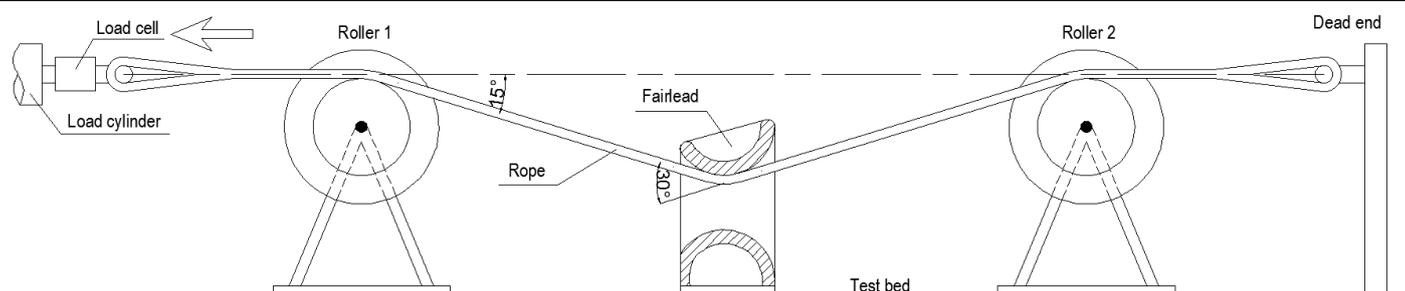
Figure 6. Hydraulic bench test – Steering cylinder on the left hand side, panama fairlead place between the two rollers, dead end on the right hand side

The applied mean load was 20% of the MBL, with a load range from 10 to 30% MBL. The test program included two steel guide rollers to deflect the rope around the surface to be tested (either a panama fairlead or steel roller). In the centre of Figure 6 the panama fairlead is shown with the two steel guide rollers on each side.

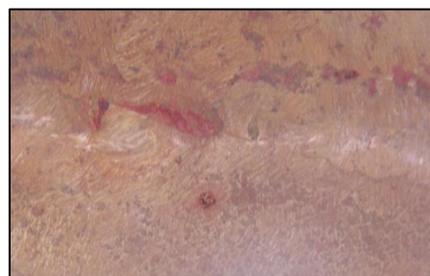
Figure 7. Fairlead un-corroded

Prior to the second wear test, and after simulated corrosion pitting, surface roughness data were obtained on key wear surfaces using a Taylor Hobson Surtronic Duo Roughness Checker. The surface roughness parameter used is Ra (Roughness average), which is the most used international parameter of roughness. The average surface roughness was Ra 254.3 µm, as contrasted with a Ra of 128.5 µm for Rope Test 1. The surface roughness conditions for Test 2 were twice greater than for Test 1. The original surface shown in Figure 7 was prior to treatment with 10% hydrochloric acid in a cellulose emulsion was mostly bright reflective silver to grey with some patches of sand texture between what appeared to be grinding marks. Moderate surface appearance and colour change noted as shown by the macro-photograph in Figure 8. The current appearance is

dull dark grey with oxide brown staining and more generalised roughness to the touch. The test surface was neutralised with common baking soda and water then flushed with tap water prior to starting Rope Test 2. Surface roughness measurements were made for each test.

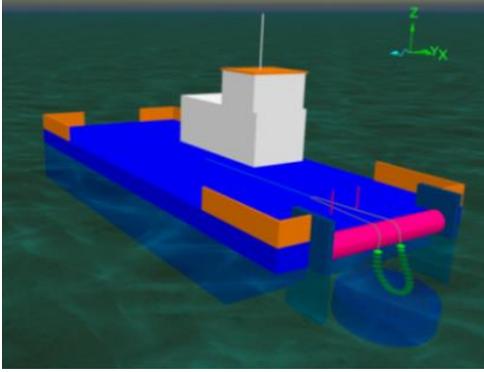
Figure 9. 3D view of the numerical modelling

However the line displacement (sliding and stretching) over the roller has been corrected with a sensitivity analysis which aimed to estimate and correct the friction forces experienced by the polyester rope on the steel roller. These friction forces were modelled through shear and normal stiffness parameters which determine the rate at which the force (prototype's weight) applied to an object (steel roller) increases with the area of contact and depth of penetration into the object. Several iterations were made until the line displacement matched the observations made.

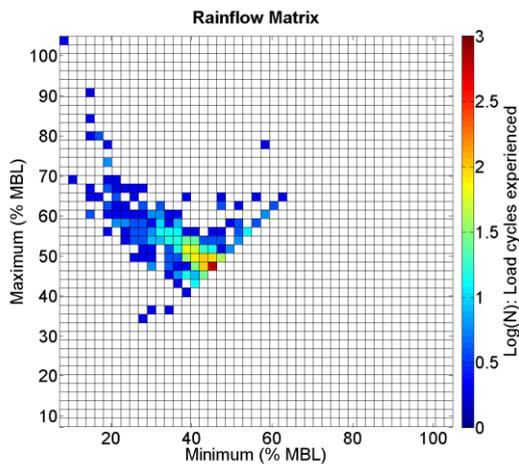
The methodology used to quantify the fatigue load during transit is similar to the method reported in [18]. The rainflow cycle counting method [19] was used to quantify the number of load cycles for different load range intervals. From this method, it is estimated that the polyester line experienced approximately 1,500 load cycles during the transit period. From the rainflow diagram presented in Figure 12, it can be observed that the mean tension range applied on the drawstring line was similar to the submerged weight of the anchor (11% MBL). The red cells indicate that the rope was subjected to low amplitude load cycles (10 – 12% MBL). However a scattered distribution of the load amplitude is visible around these red cells. It is an indicator of the occurrence of higher load amplitudes (8 – 14% MBL). The load cycles in the upper left corner cells have the largest amplitudes and will thus result in the largest fatigue damage including the occurrence of occasional very large load amplitudes (2 – 26% MBL). Due to the low number of cycles the rope has experienced and the outcomes of the SEM, it can be concluded that fatigue was not the governing failure cause.

Figure 12. Rainflow matrix calculated from the simulated load history

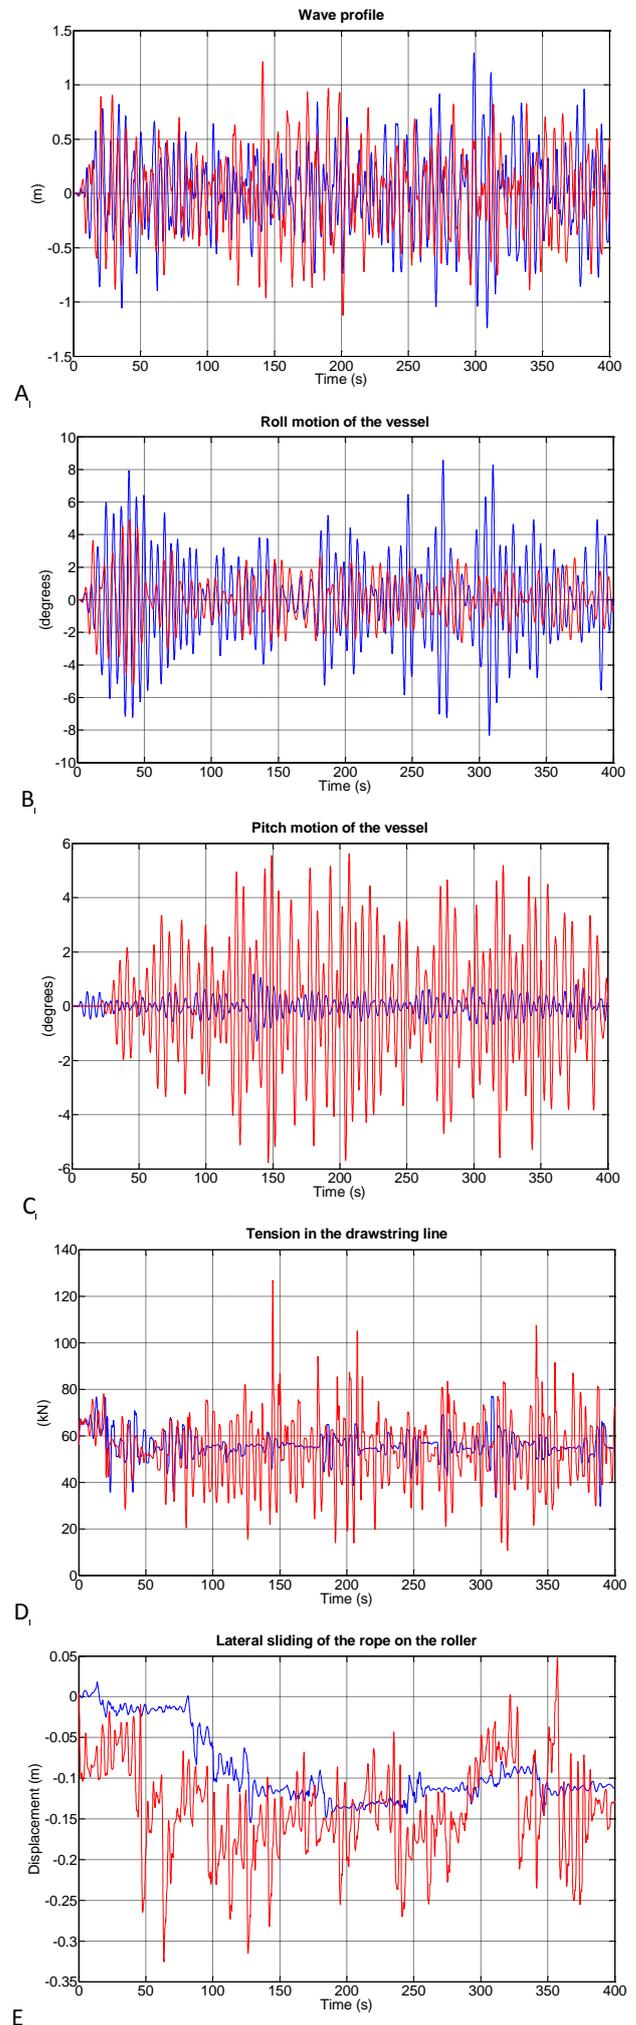
For the same significant wave height, the plots presented in Figure 11 show the significant influence of wave direction on the vessel response and lateral sliding of the rope. A sample of dataset of 400 seconds was chosen to facilitate the viewing of the results. As shown in plot E the lateral sliding of the roller is 2.5 times greater when the wave direction approached the vessel with a 55° angle. The large dispersion of the signal for the lateral movement is an indicator of the occurrence of important friction forces on the rope.

Figure 11. Comparison between two numerical model output – $H_s = 1.5\text{m}$ 90° heading sea in blue and $H_s = 1.5\text{m}$ 55° heading sea in red

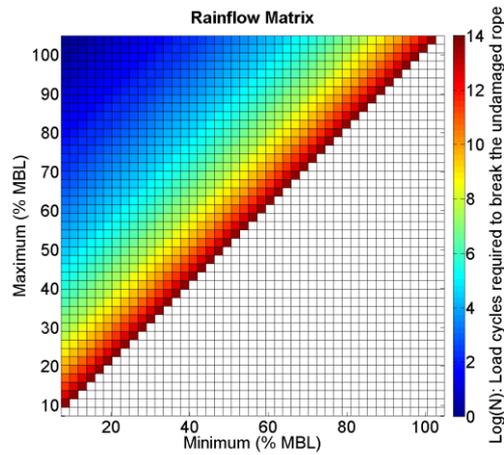
Figure 13 shows the number of load cycles for each load range which would have been necessary to break the undamaged polyester rope. This graph is obtained by applying Eq. 4 to each load range for the polyester line's characteristics as given in section 3.1. This graph is unduly optimistic since the rope bearing capacity was decreasing over the time due to wear caused by abrasion.

Figure 13. Rainflow matrix calculated from Eq. 4 showing the load cycles required to break the un-damaged polyester rope
