Impact of Flood Disasters on Taiwan in the Last Quarter Century

WEI-HSIEN TENG^{*1}, MING-HSI HSU², CHUNG-HSING WU³, ALBERT S. CHEN⁴

Abstract. The increasing natural disasters, especially floods, are raising the economic losses in Taiwan during the last quarter century. The most severe hazard in Taiwan is flooding induces by typhoons and storms in summer and autumn. By comparing the rivers around the world, the ones in Taiwan have the steepest slopes, the largest discharge per unit drainage area, and the shortest time of concentrations. The quick urbanizations without proper land uses managements usually worsen the flood problems. Consequently, flood hazards mitigation has become the most essential task for Taiwan to deal with. Although the government keeps improving flood defense structures, the flood damage grows continuously. In this article, possible flood mitigation strategies are identified for coping with complex environmental and social decisions with flood risk involved.

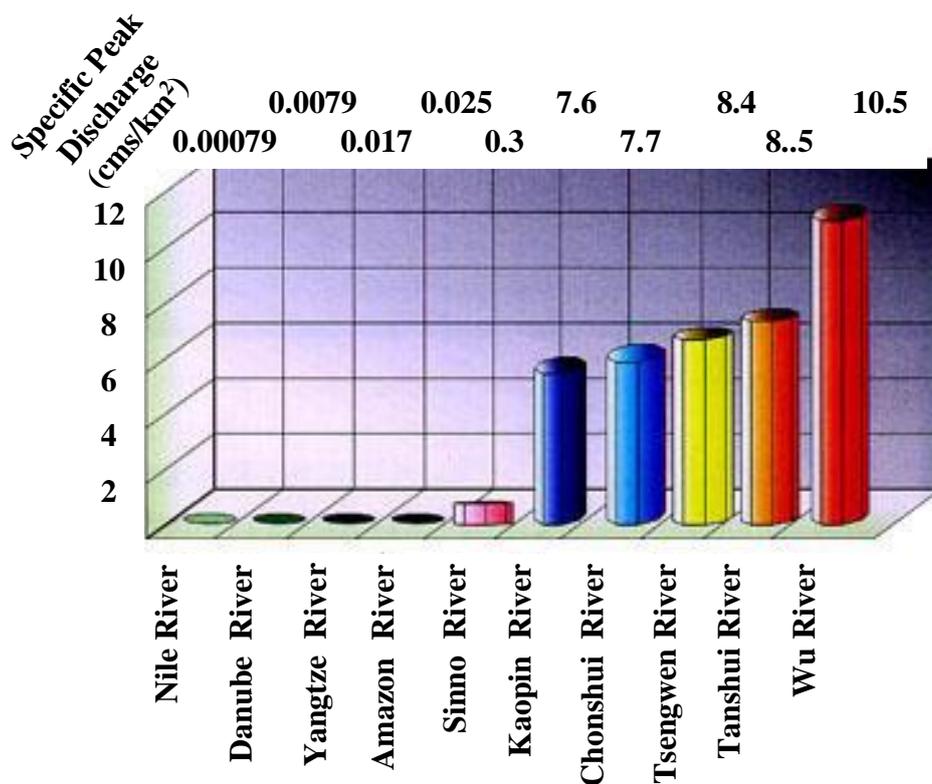
Figure 1. Comparison of specific peak discharges in rivers around the world

The annual rainfall in Taiwan reaches 2,500 mm, which is 2.5 times the world average. However, 75% of the annual rainfall concentrates in the period from May through October. There were 350 typhoons, and over 1,000 storms occurred in Taiwan in the last century. The statistics show that losses due to natural disasters reached 365 million US dollars from 1983 to 1995. The amount is approximately 4.6 times of fire damages in the same period. The peak discharge per unit drainage area in Taiwan is the largest in the world. For instance, the specific peak discharge of Choshui River is 450 times that of the Yangtze River in China and 25 times that of the Sinno River in Japan. The comparison of specific peak discharges in the world is shown in Figure 1, and all of the rivers whose specific peak discharges are larger than the Sinno River's are in Taiwan.

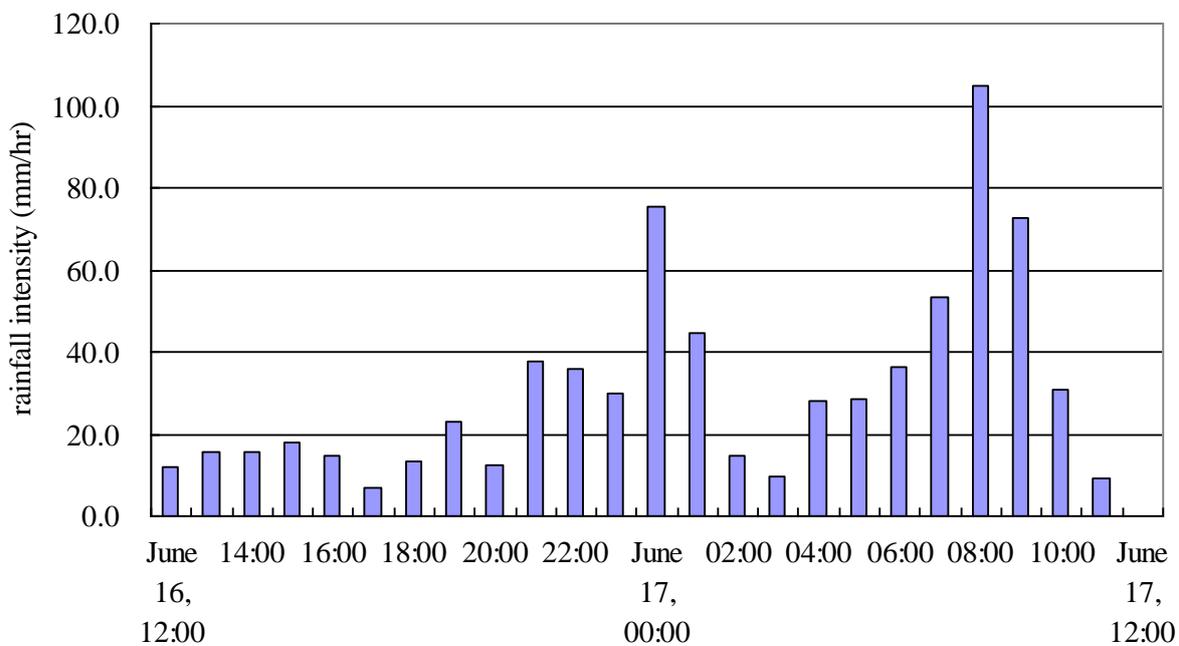
Figure 2. Historical rainfall records of Nan-Gun rain gage in Typhoon Nali

On September 17th, 2001, the mountains in the northeastern Taiwan suffered from a heavy rainfall brought by typhoon Nari. According to the CWB's report, typhoon came through the Keelung River from the sea with threatening rain clouds that caused torrential rainfall. In the Nankang District of Taipei, the rainfall intensity increased from 4 a.m. (shown in Figure 2), the hourly rain amounted to 105 mm at 8 a.m. and 73 mm at 9 a.m., respectively. The 12-hour rainfall from 4 a.m. to 4 p.m. amounted to 530 mm.

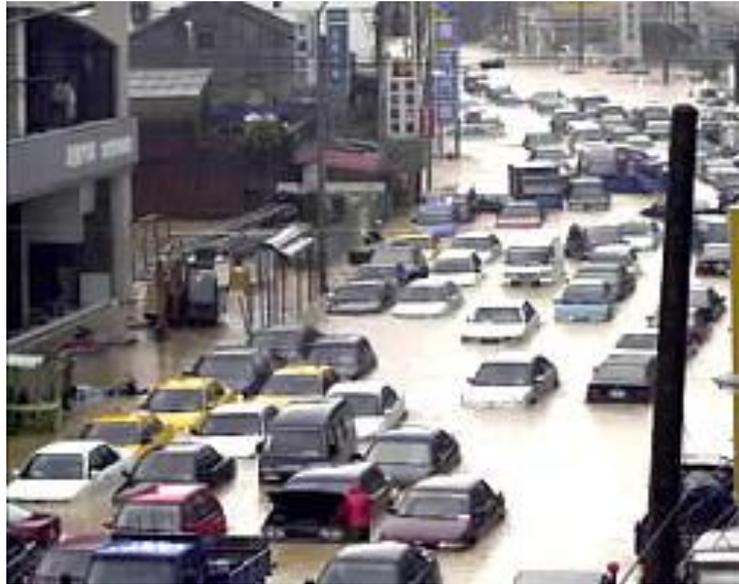
Figure 3. Numerous cars were submerged in the storm Typhoon Nali.

inundation of a wide area of Taipei city, which is located in the northern part of Taiwan. The flood intruded into the substructure space, namely, the rapid transit system, the subway stations, and the basements in buildings and underground shopping malls, which caused heavy damages. There were 104 casualties or missing persons in this storm. The losses were so huge at the Taipei City government and most experts believed that the direct losses should be more than 20 million US dollars. Figure 3 shows numerous cars were submerged in Typhoon Nali storm and people deal with the enormous waste after the flood in Figure 4.

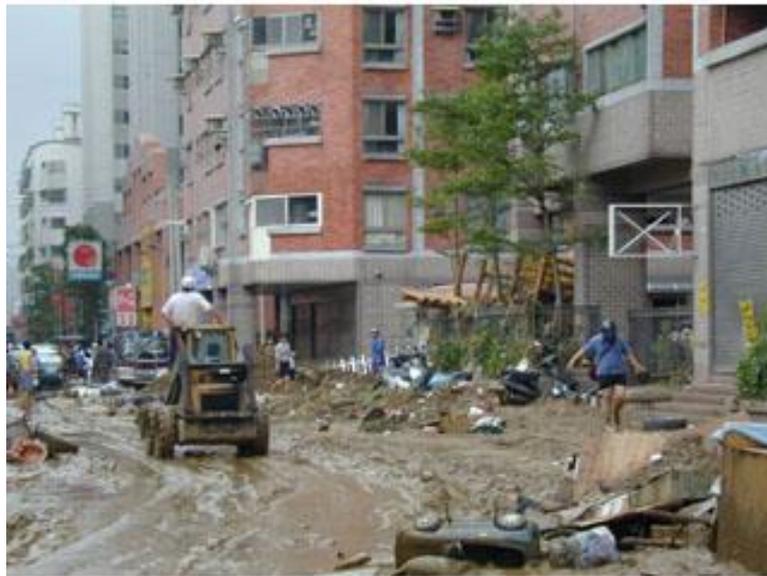
Figure 4. People deal with enormous waste after the storm Typhoon Nali.

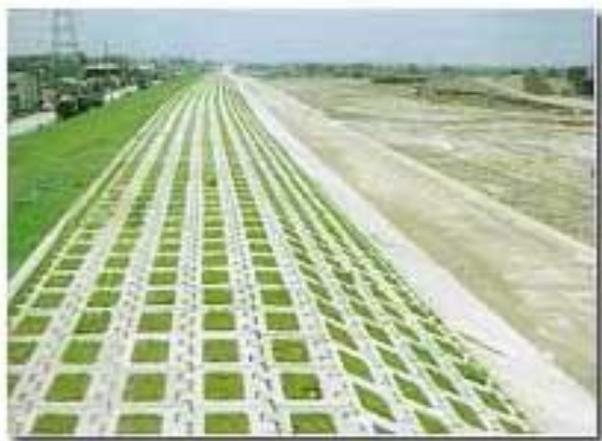
Figure 5. Dike construction employing ecology methods

7. Plans to implement new flood mitigation and flood-proofing measures by ecological methods for individuals and communities – if sound in economic, environmental, engineering and social terms – should continue as rapidly as possible. All such measures, whether by government or individuals, should be coordinated and examined to determine possible damage to others within the basin.

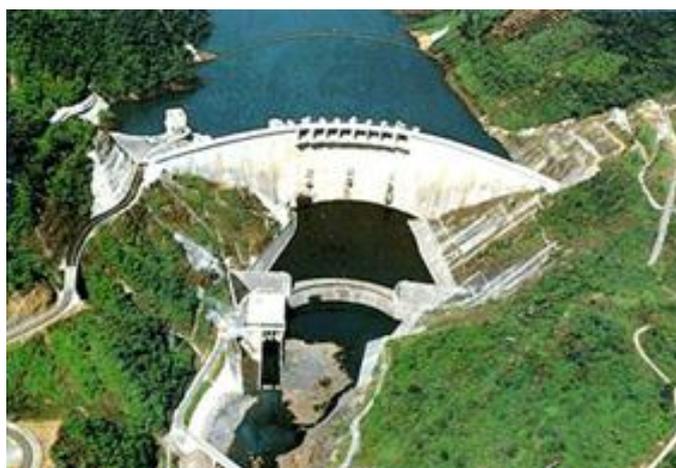
Figure 6. Overview of the Feidui reservoir in Taiwan

During the period of Typhoon Herb, those eleven flood control reservoirs stored approximately 900 million cubic meters of flood flow; among them, Feidui Reservoir (shown in Figure 6) stored 370 million cubic meter of flood flow.

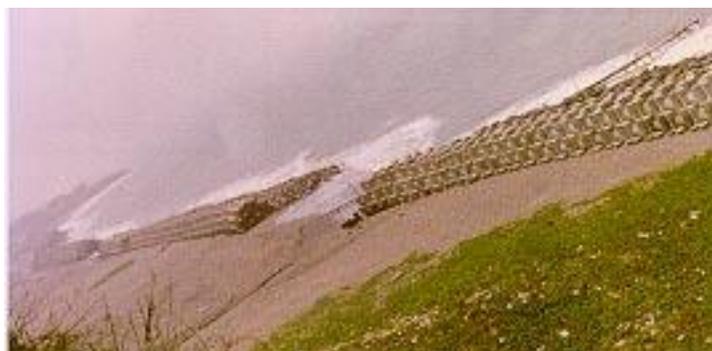
Figure 7. Coastal protection along Ginshan beach in Taipei County

It is very important to protect the long coast line in Taiwan. In addition to installing tidal stations, coastal protection and coastal dikes are the two most commonly used protection facilities. Figure 7 shows the coastal protection along Ginshan beach in Taipei County. In order to improve scenery and sustainable use of coastal resources, improvements with a natural look should be actively pursued now around Taiwan.
