INNOVATIVE INSTRUMENTATION TO STUDY THE BEHAVIOUR OF A HIGH-RISE BUILDING

Dr. Tso-Chien PAN¹, Associate Professor

Dr. James M. W. BROWNJOHN¹, Senior Lecturer

¹ School of Civil and Structural Engineering

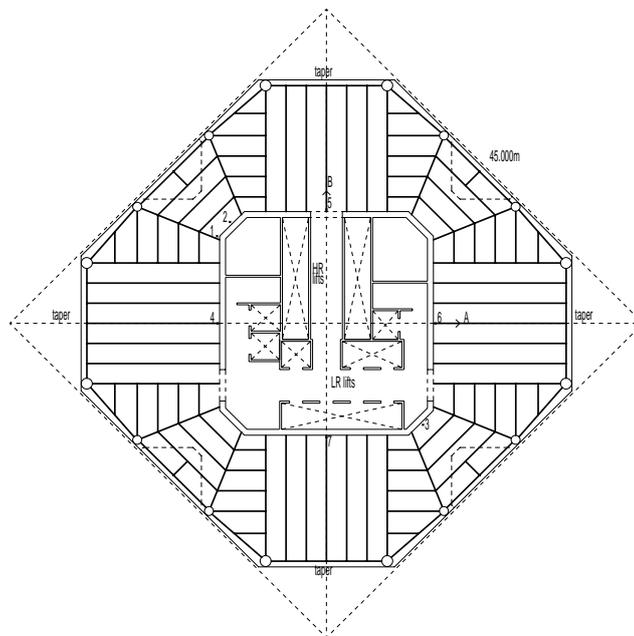
Figure 1: Republic Plaza, showing tapering and non-tapering aspects

Republic Plaza (Figure 1) is Singapore's tallest building, with a total height of 280 m above sea level (limited by local aviation regulations) and 281 m above the basement. It has 67 levels from the first basement (B1) to roof level (66th storey) and is the subject of a continuing investigation in which static and dynamic responses are being monitored.

Figure 2 shows the floor plan at level 19 which is above the vertical recess visible in Figure 1 and shown dotted in Figure 2, and below the taper visible in Figure 1. The tower comprises a reinforced concrete (RC) central core, peripheral steel columns, a steel floor beam system between core wall and columns and RC slabs inside and outside the core.

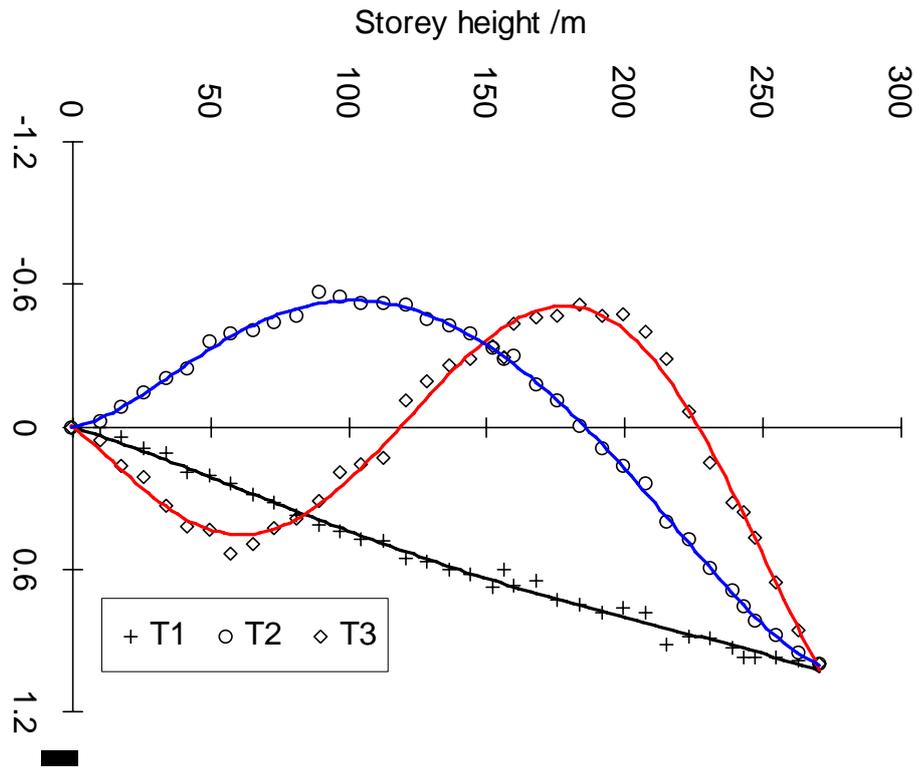
Figure 9: Mode shapes in B-direction

Mode shapes are given in Figures 8 to 10 for the first three A-direction, B-direction and torsional modes based on measurements at location '1' and normalised to unit value at level 65. The solid lines are best fit (degree 6) polynomials. The mode shape values are obtained from averaged cross-power spectra between signals at two positions at the resonant frequency common to both signals. In most cases the spectra are averaged over 16 records and points closely follow the best fit lines, but where fewer or weaker records were used the data points are scattered. For the torsional modes the points are normalised B-direction translational response magnitudes and show greater scatter since the values of ϕ are sensitive to small errors in accelerometer orientation. Data points for torsional modes at roof level, where there is no core wall, are less than 1.0 (and are not shown) since the accelerometers could not be located at the equivalent location '1'.
